**NUMBER:** 08-004-15 REV. A

**GROUP:** Electrical

FLASH: Battery Electric Vehicle, Multiple System Enhancements

2013 - 2015                      (FF)                      Fiat 500e

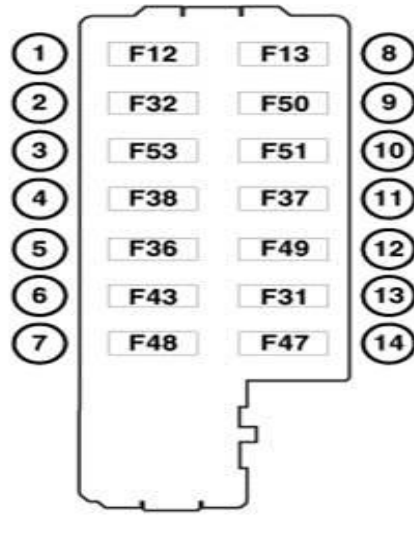
**Fig. 1 Interior Fuse Panel Located By The Left Kick Panel.**

13. Is U11F6-00 set as an active fault?
  - a. Yes >>> Proceed to [Step #14](#).
  - b. No >>> Proceed to [Step #16](#).
14. Turn off the ignition and pull fuse F36 for 10 seconds. It is located in the interior fuse panel, which is part of the BCM, see ([Fig. 1](#)).

Remove fuse F36 .
