## SERVICE BULLETIN

EC18-028

September 11, 2018

### 2018 ARMADA; MIL ON WITH DTC P0138 AND/OR P0158

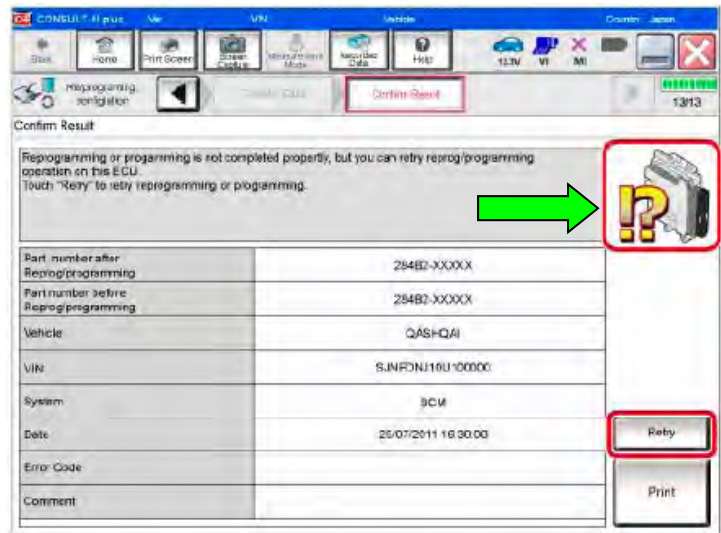
Figure 6

If reprogramming does not complete and the “!” icon displays as shown in Figure 6:

- Check battery voltage (12.0 - 15.5 V).
- Ignition is ON, engine OFF.
- External Bluetooth® devices are OFF.
- All electrical loads are OFF.
- **Select retry and follow the on screen instructions.**
- **“Retry” may not go through on first attempt and can be selected more than once.**

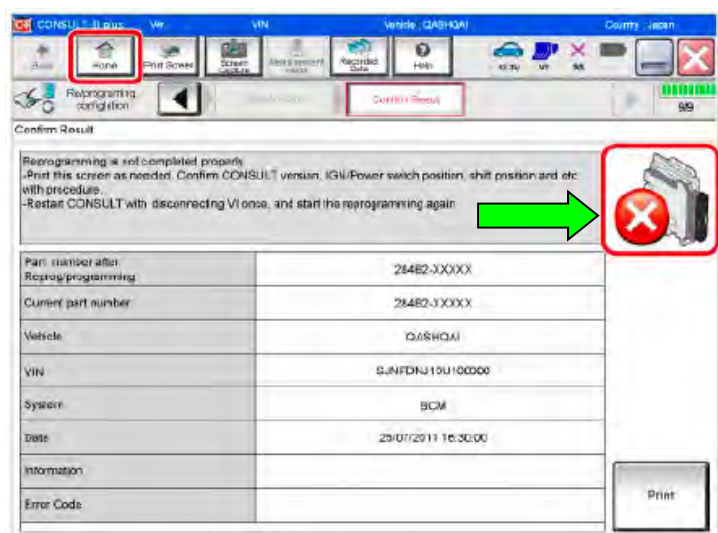
Figure 7

If reprogramming does not complete and the “X” icon displays as shown in Figure 7:

- Check battery voltage (12.0 - 15.5 V).
- CONSULT A/C adapter is plugged in.
- Ignition is ON, engine OFF.
- Transmission is in Park.
- All C-III plus / VI cables are securely connected.
- All C-III plus updates are installed.
- **Select Home, and restart the reprogram procedure from the beginning.**
