## SERVICE BULLETIN

| EC19-005 | NTB19-011 | February 28, 2019 |

### 2016 – 2018 TITAN XD; MIL ON WITH DTC P2048 STORED

**APPLIED VEHICLES:** 2016 – 2018 Titan XD (A61)  
**APPLIED ENGINE:** Cummins 5.0L Diesel

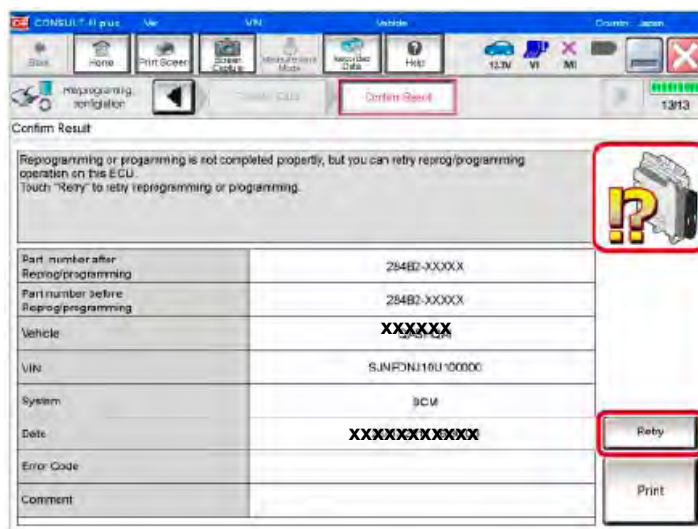
Figure 5

If reprogramming does not complete and the “!?” icon displays as shown in Figure 5:

- Check battery voltage (12.0 - 15.5 V).
- Ignition is ON, engine OFF.
- External Bluetooth® devices are OFF.
- All electrical loads are OFF.
- **Select retry and follow the on screen instructions.**
- **“Retry” may not go through on first attempt and can be selected more than once.**

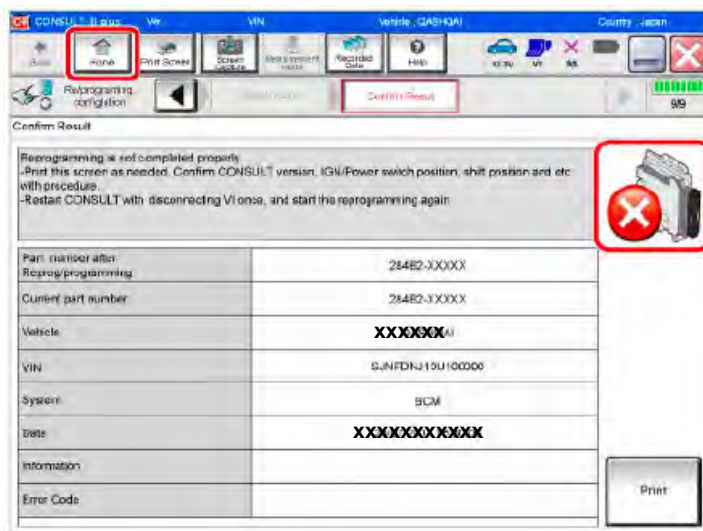
Figure 6

If reprogramming does not complete and the “X” icon displays as shown in Figure 6:

- Check battery voltage (12.0 - 15.5 V).
- CONSULT A/C adapter is plugged in.
- Ignition is ON, engine OFF.
- Transmission is in Park.
- All C-III plus / VI cables are securely connected.
- All C-III plus updates are installed.
- **Select Home, and restart the reprogram procedure from the beginning.**
