Bulletin No.: PIT5659  
Published date: N/A

## PIT5659 Driver Side Power Seat Inoperative

| Brand: | Model: | Model Years: | VIN: | | Engine: | Transmissions: |
|---|---|---|---|---|---|---|
| Chevrolet | Blazer | 2019 | All | All | All | All |

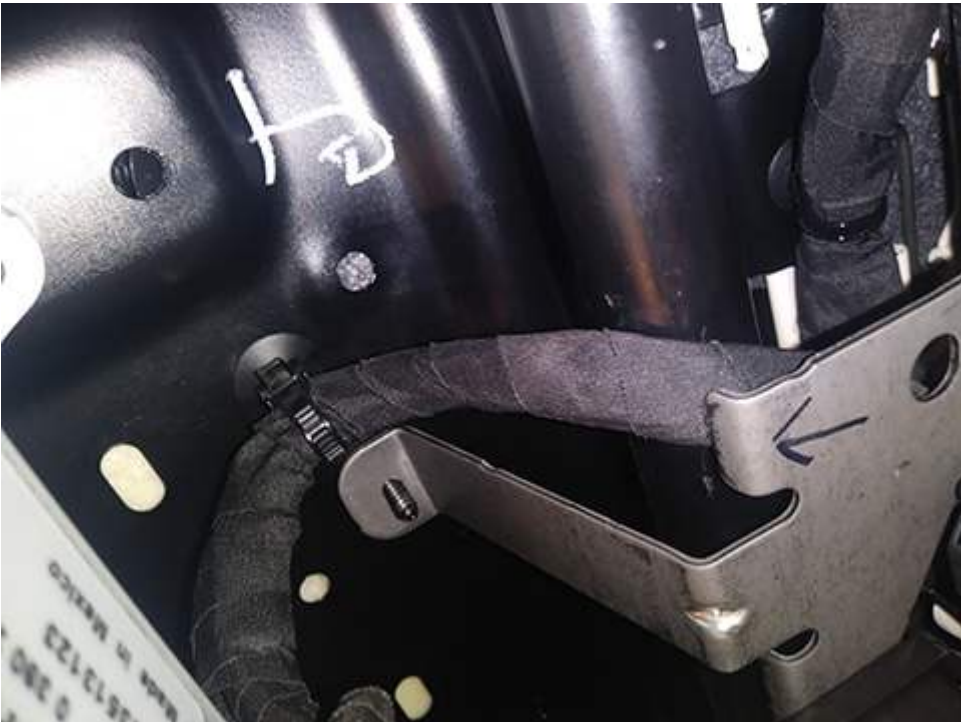
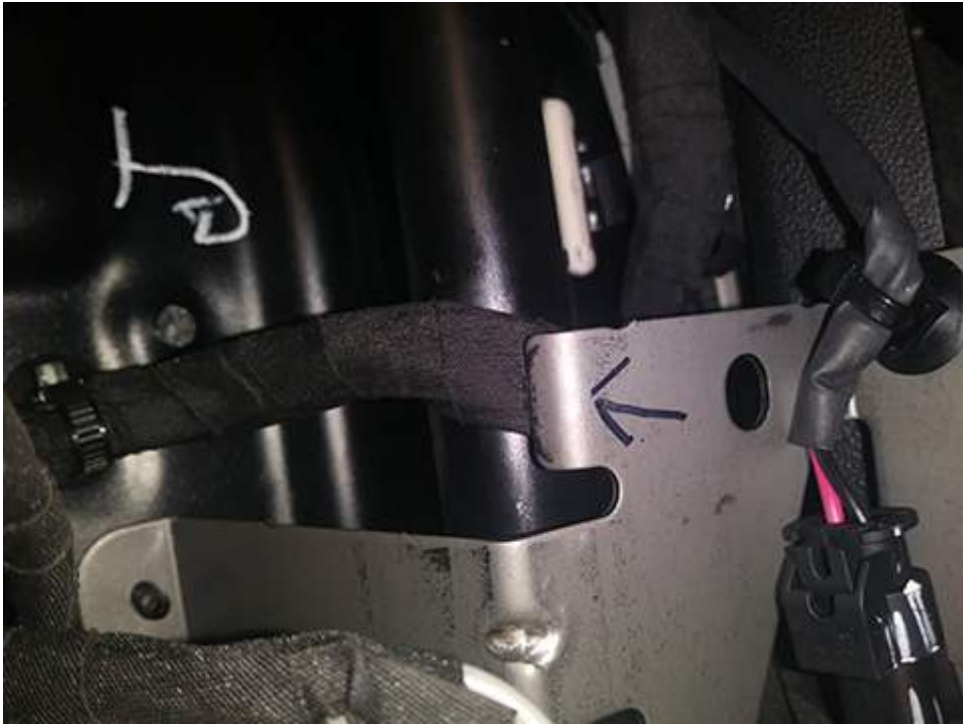
| Cause | The wire harness may be pinched between the memory seat module bracket and the seat cushion frame tube. |

Inspect the seat harness for being improperly routed and pinched between the memory seat module bracket and the seat frame tube.

Repair or replace the seat harness as needed and re-route it so that it will not become pinched or damaged.
