Preliminary Information

PIT5677 SES MIL / No Start / No Crank / Runs Rough / Reduced Engine Power / VSS / DTC's (Inspect Engine Harness)

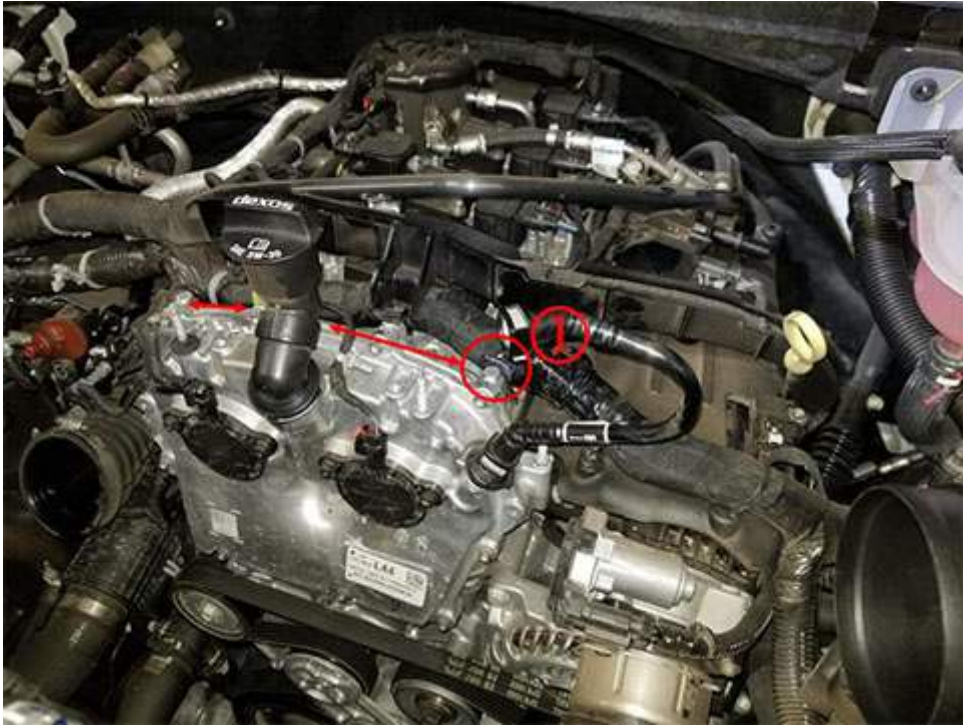
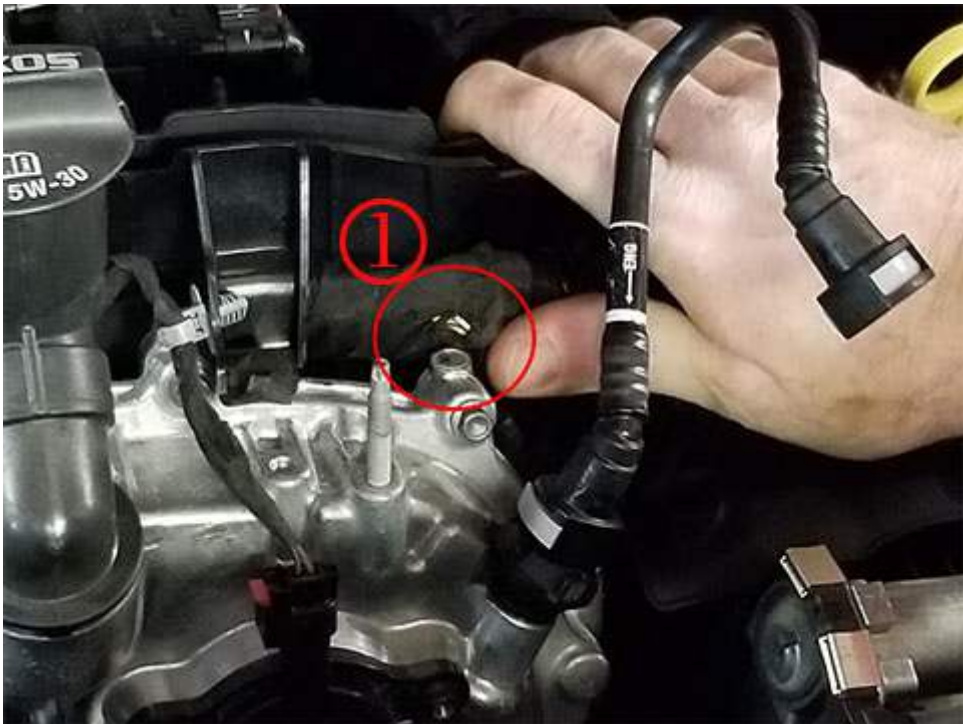
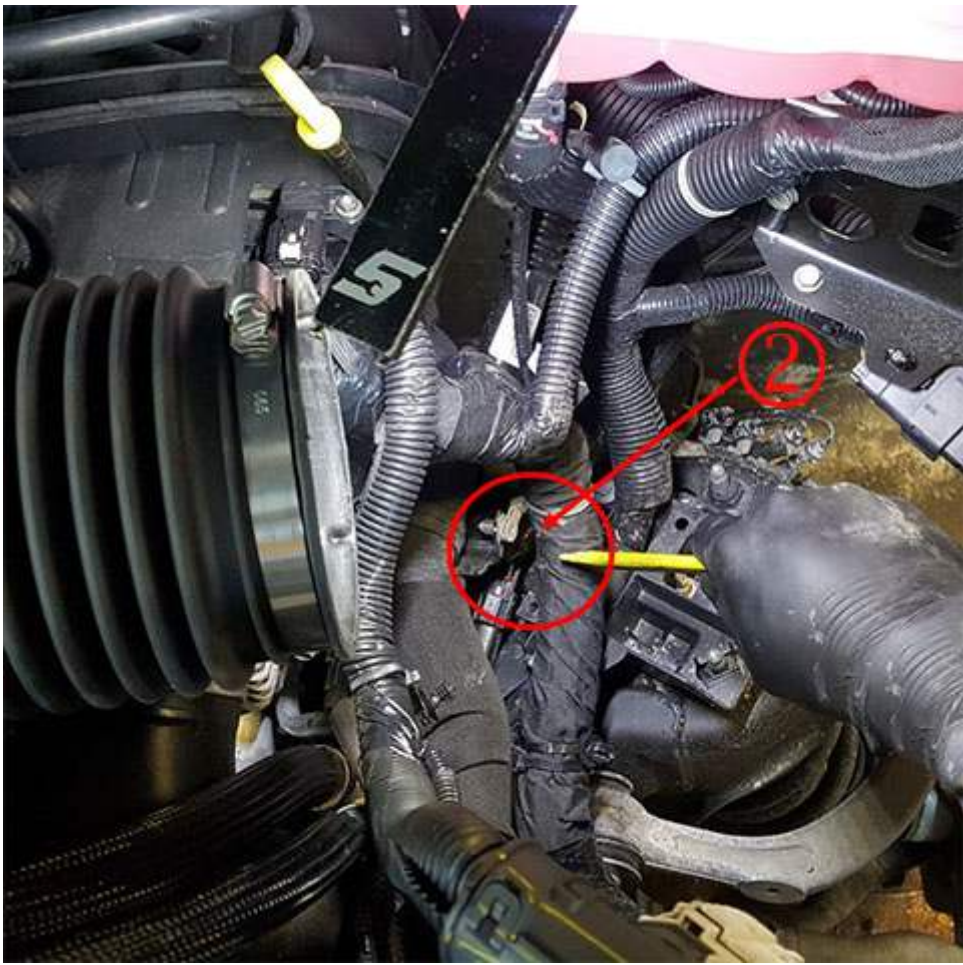
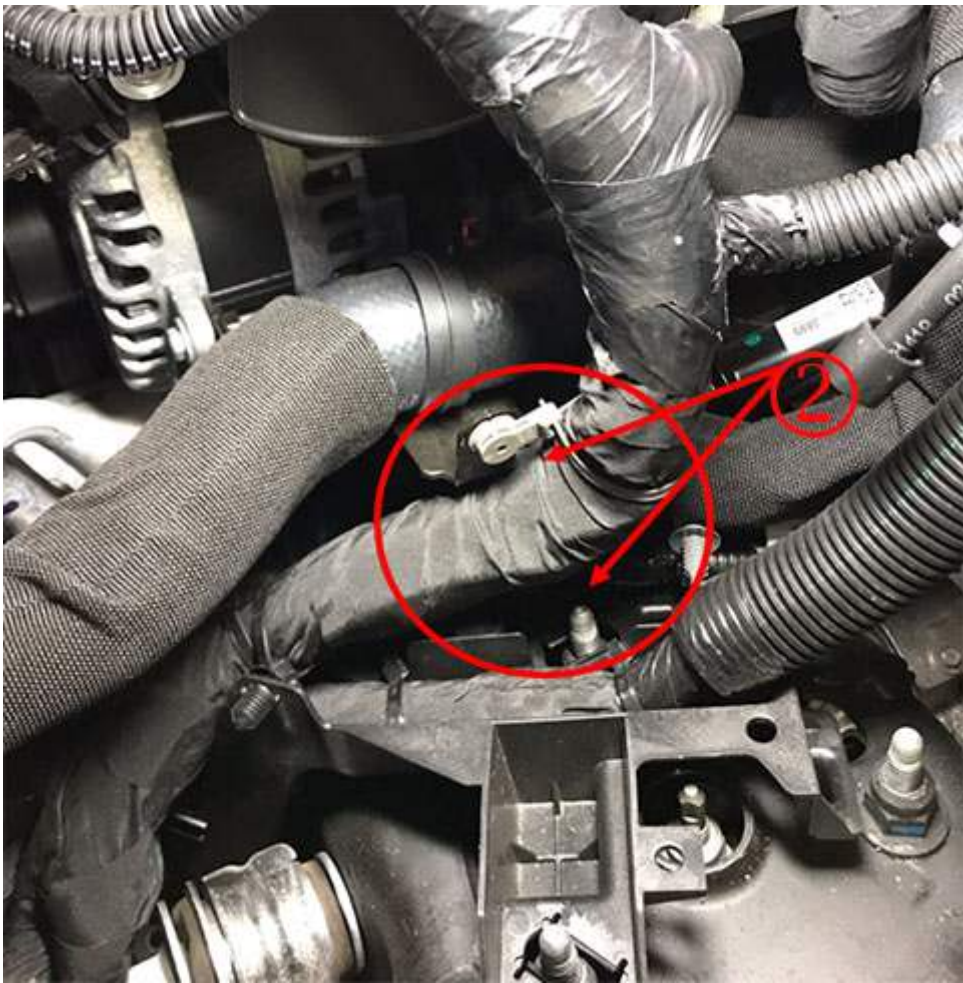
| Cause | <p>These concerns could be caused by the engine harness shorting to ground. The following two areas should be inspected for this concern:</p> <ul style="list-style-type: none"><li>- Inspect the engine harness as it crosses over top of the camshaft carrier housing, as shown below in call out 1. The short can occur at any point across the camshaft carrier housing and the close-up photo below shows an example of this concern.</li><li>- Inspect the engine harness below the air filter housing/above the left shock tower, as shown below in call out 2. The short can occur on the bracket for the radiator hose or on left upper shock mounting studs.</li></ul> |

Repair any damaged wiring as necessary and protect the harness to prevent the issue from reoccurring.
