GLOBAL SAFETY FIELD INVESTIGATIONS  
DCS5117  
URGENT - DISTRIBUTE IMMEDIATELY

Subject: N182188250 - Special Coverage  
Loss of Continuity within Accelerator Pedal Position Sensor Circuit

Models: 2017-2018 Buick LaCrosse  
2018 Buick Regal  
2016-2018 Chevrolet Malibu

## N182188250 Loss of Continuity within Accelerator Pedal Position Sensor Circuit

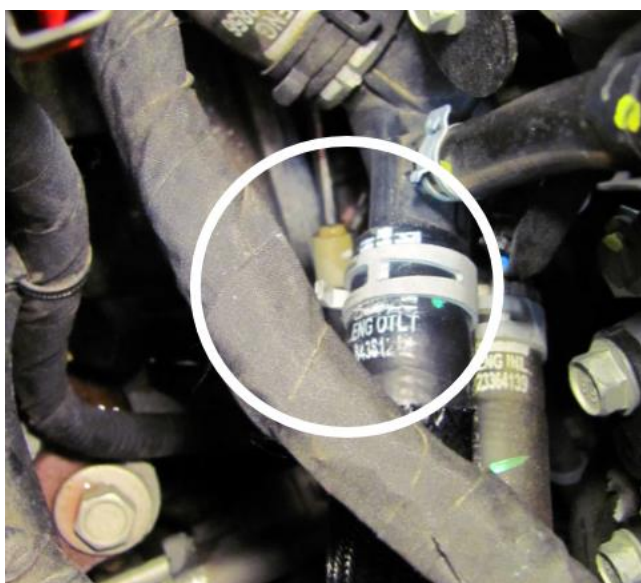
2. On Malibu (LFV engine) applications **only**, inspect the engine wire harness adjacent to the heater inlet hose for contact with the heater inlet hose clamp on the engine outlet portion of the hose as shown.

**Caution:** The heater hose clamp may be glued to the heater hose. If the clamp is glued to the heater hose, **do not** attempt to rotate the heater hose clamp, as heater hose damage may occur and clamp may have residual rubber material on it. Instead, replace the heater hose and both clamps.

3. If contact is observed between the heater hose clamp and the engine wire harness, attempt to rotate the heater hose clamp tabs away from the engine harness, ensuring the clamp stays within the alignment guide markings.

- If the heater inlet hose clamp is **not** glued to the heater inlet hose, rotate the heater inlet hose clamp so the tabs are facing away from the engine wire harness. Ensure the clamp stays within the alignment guide markings. There should be at least  $\frac{3}{4}$  inch (19mm) of clearance between the heater hose clamp tabs and the engine wire harness.

- If the heater hose clamp **is** glued to the heater hose, replace the heater inlet hose and both heater hose clamps, being sure to clock the heater inlet hose clamps so the tabs are facing away from any adjacent engine wire harnesses. Ensure the clamp stays within the alignment guide markings. Refer to *Heater Inlet Hose Replacement (LFV)* in SI.

- If any damage is observed to the engine harness, repair the harness and the affected circuits. Refer to *Wire to Wire Repair* in SI. Rewrap the harness in the affected area with PET tape in addition to clocking the hose clamp away from the harness to ensure another rub-through event is no longer possible.
