## SERVICE INFORMATION BULLETIN

**APPLICABILITY:** 2020MY Legacy and Outback  
 2019-20 Impreza  
 2019-20MY Crosstrek / Crosstrek Hybrid  
 2019-20 Forester  
 2019-20 Ascent  
 All Models as Listed with Gen 2 Telematics

**NUMBER:** 15-251-19

**SUBJECT:** DTC B2A16

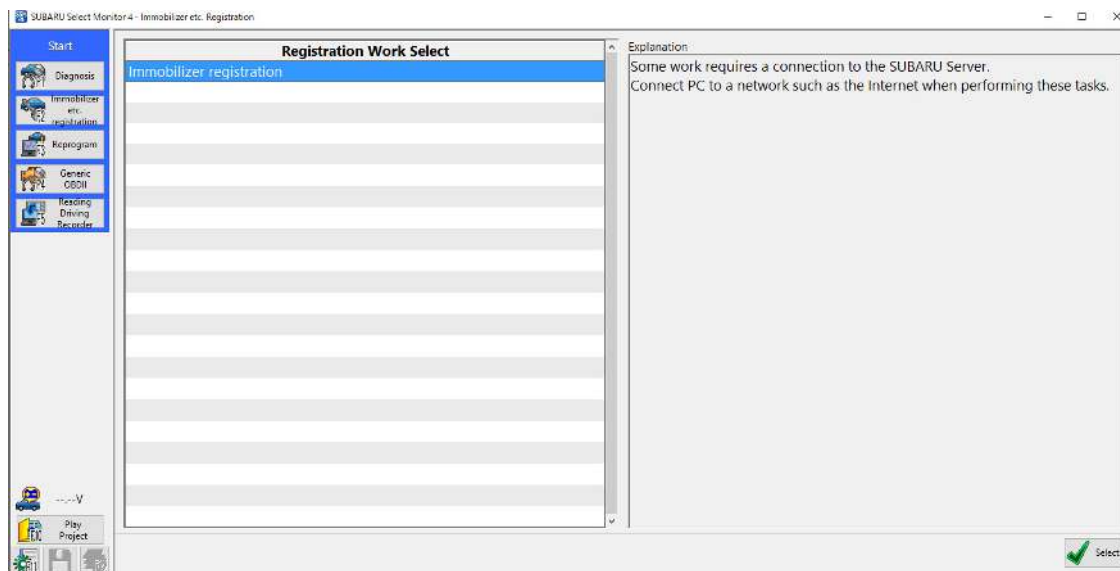
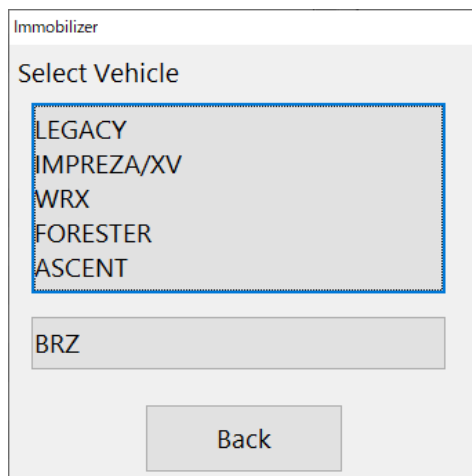
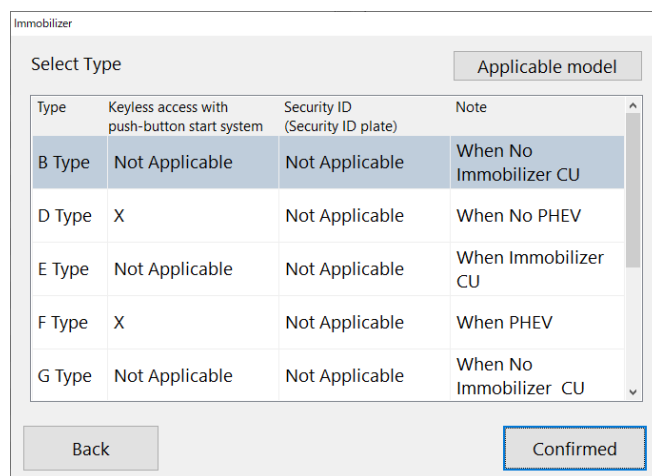
If DTC B2A16 is found in the DCM, start by registering the DCM with the vehicle immobilizer system to avoid a potentially unnecessary DCM replacement. Follow the instructions found in the applicable Immobilizer Registration Manual. See the basic SSM screenshots and additional information provided below for reference.

Once the DCM is registered, confirm the Telematics RES function operates. **NOTE:** The customer will need to help with this as it requires them to enter their PIN through either the MySubaru web page or the mobile MySubaru App.

If registering the DCM with the vehicle immobilizer system resolves the condition and STARLINK Telematics RES now operates normally, clear the DTC and release the vehicle.
