RS19-005

ITB19-024

September 12, 2019

## DTC B00A0-00 STORED

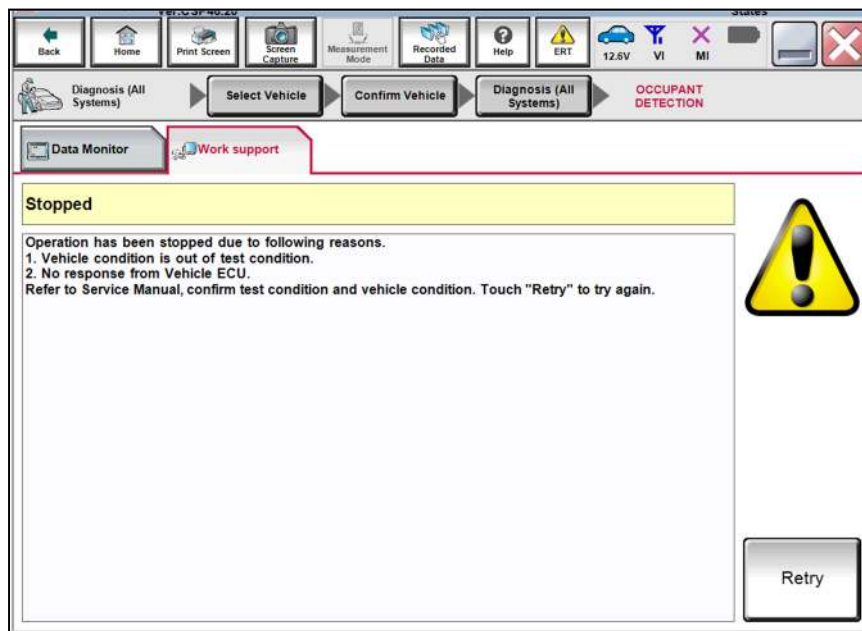
Figure 1

DTC B00A0-00 (OCCUPANT DETECTION SENSOR UNIT) is stored

OCS zero point reset cannot be performed

The following screen will display:

1. Check the Occupant Classification System (OCS) control unit using the ODS Analysis tool software.
  - Refer to SERVICE PROCEDURE on the next page.

2. Perform "75-zero RESET".

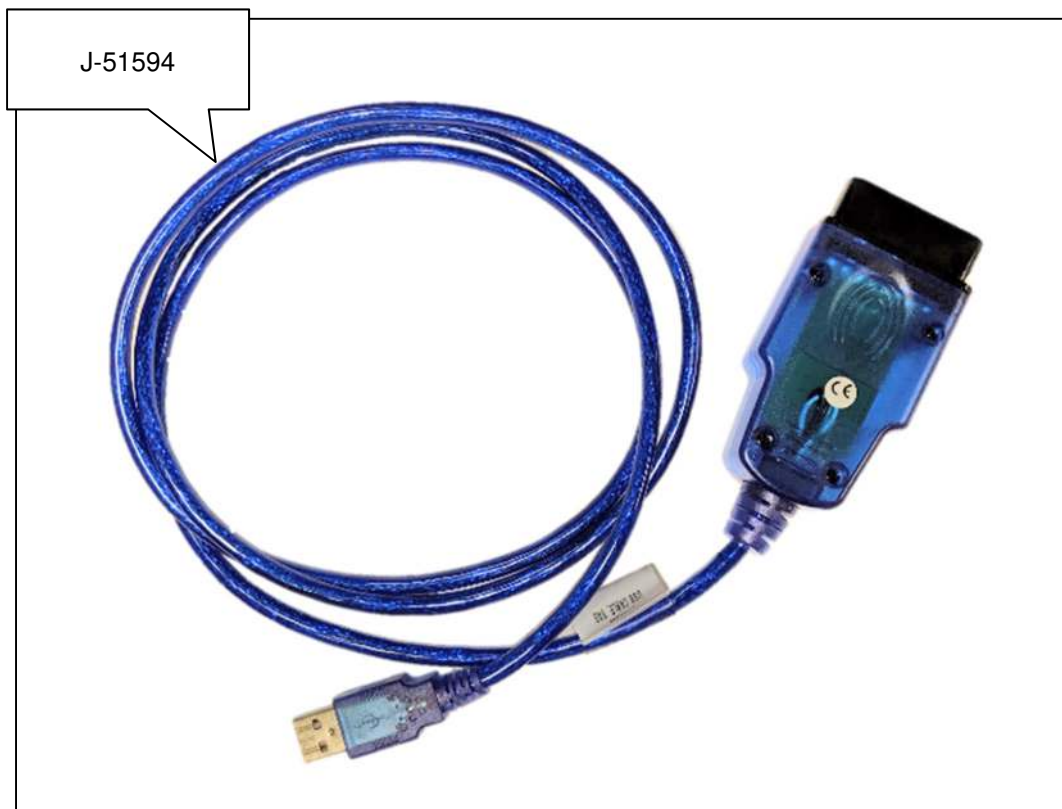
Figure 2

REQUIRED SPECIAL TOOL: OCS Reprogramming Cable J-51594

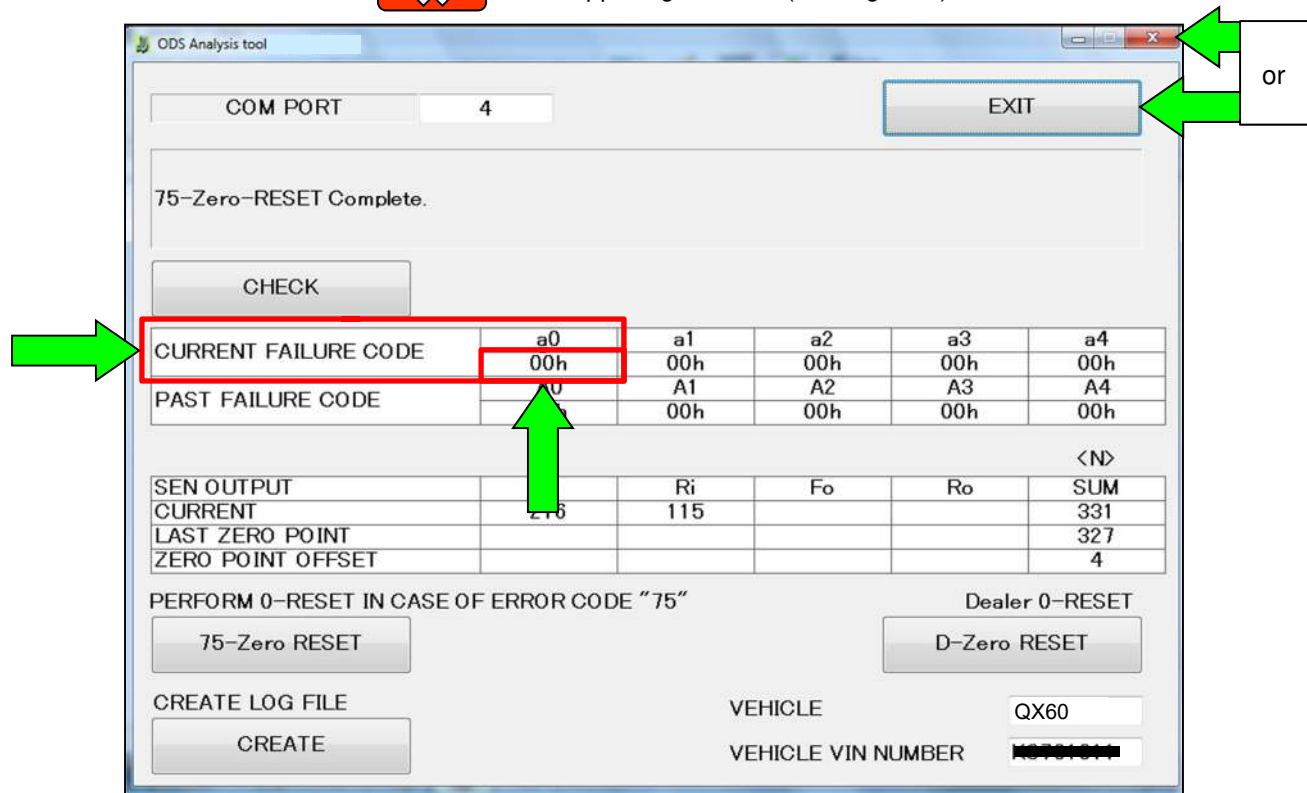
16. When the screen in Figure 9 displays, the 75-zero reset process is complete.
  - Verify code 75h is not displayed under CURRENT FAILURE CODE.
17. Select either EXIT or the
