## SERVICE BULLETIN

NTB19-071

### DTC B00A0-00 STORED

DTC B00A0-00 (OCCUPANT DETECTION SENSOR UNIT) is stored

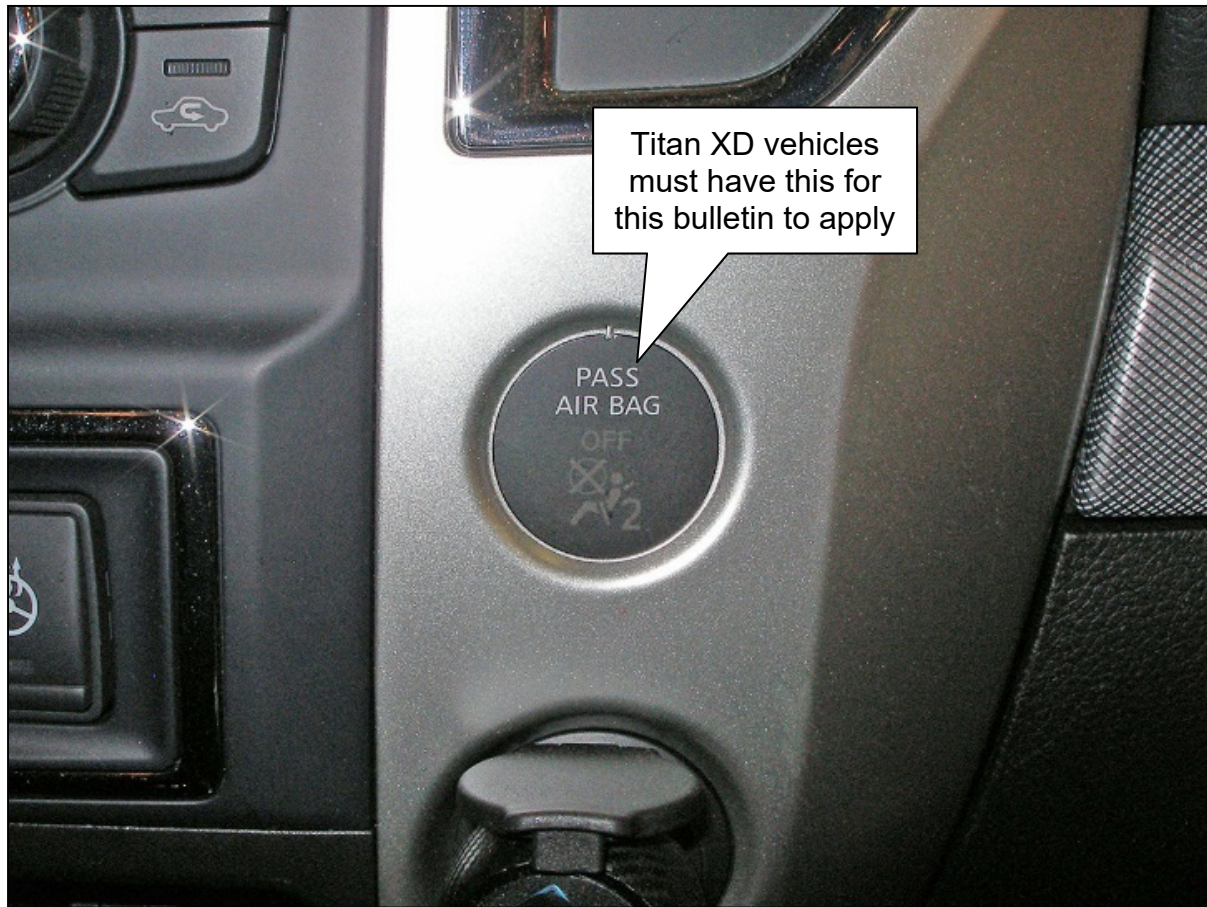
Figure 3

- Titan vehicles: This bulletin applies to ALL Titan vehicles.
- Titan XD vehicles: This bulletin does NOT apply to all Titan XD vehicles. This bulletin applies to Titan XD vehicles equipped with OCS, as indicated by the presence of a front passenger air bag status light (see Figure 3).

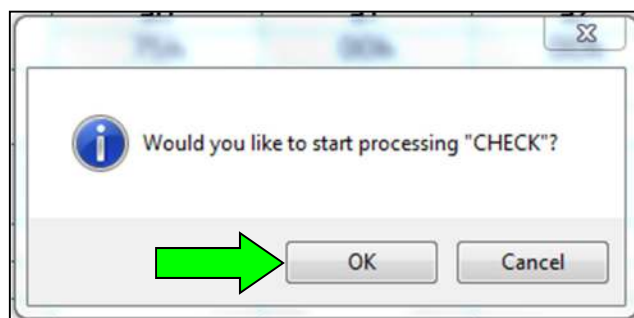
Figure 6

12. Check for code 75h to show under **CURRENT FAILURE CODE**.

- If code 75h shows under **CURRENT FAILURE CODE**, go to step 13.
- If code 75h does NOT show under **CURRENT FAILURE CODE**, STOP HERE. This bulletin does not apply. Refer to ASIST and the ESM for further diagnostic assistance.

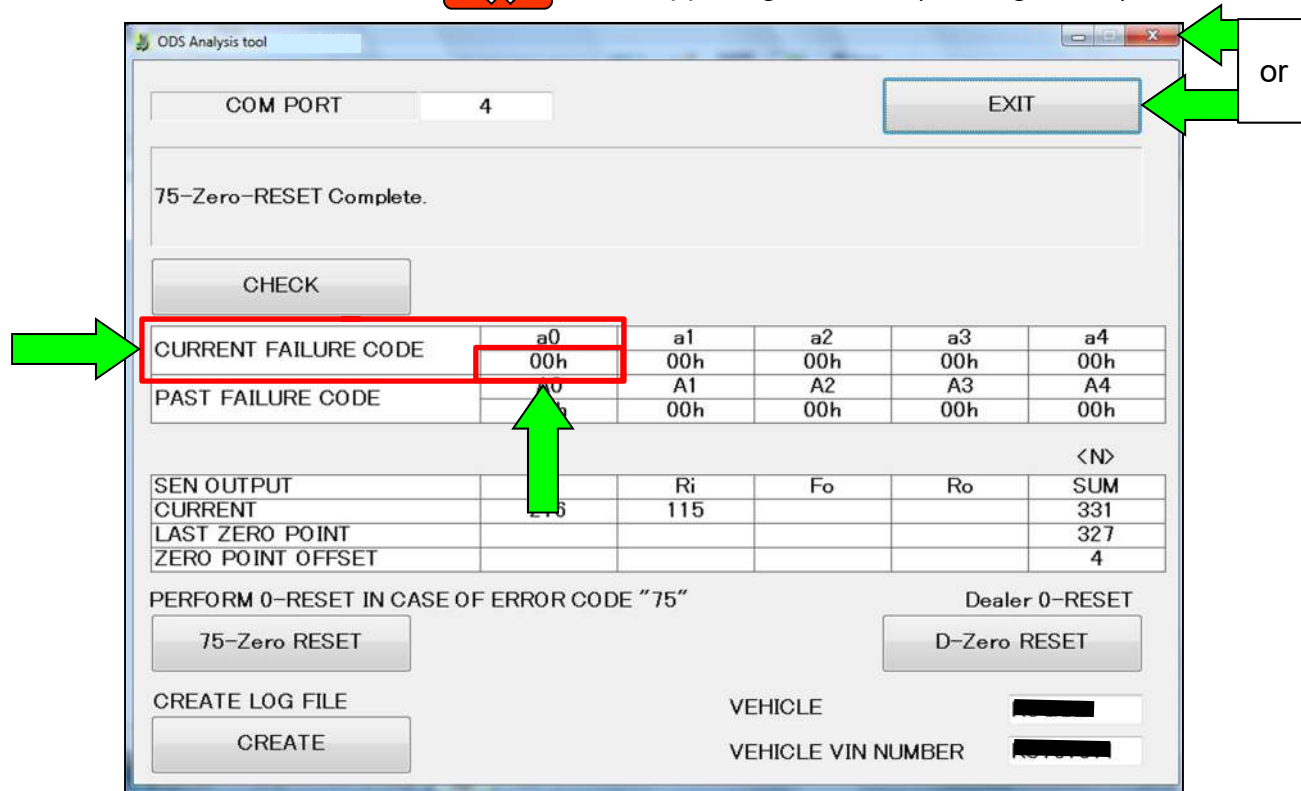
17. When the screen in Figure 10 displays, the 75-zero reset process is complete.
  - Verify code 75h is not displayed under **CURRENT FAILURE CODE**.
18. Select either **EXIT** or the

in the upper right corner (see Figure 10).
