Preliminary Information

PIT5713 SES MIL / IPC Gauges Sweep / IPC Warning Message / Reduced Engine Power / Loss Communication / DTCs U0073 U0100 U0101 u0121 U0128 U0129 U0131 U0140 U0146 U0422 U2413 P0107 P0641 C2A07 (Inspect Engine Harness)

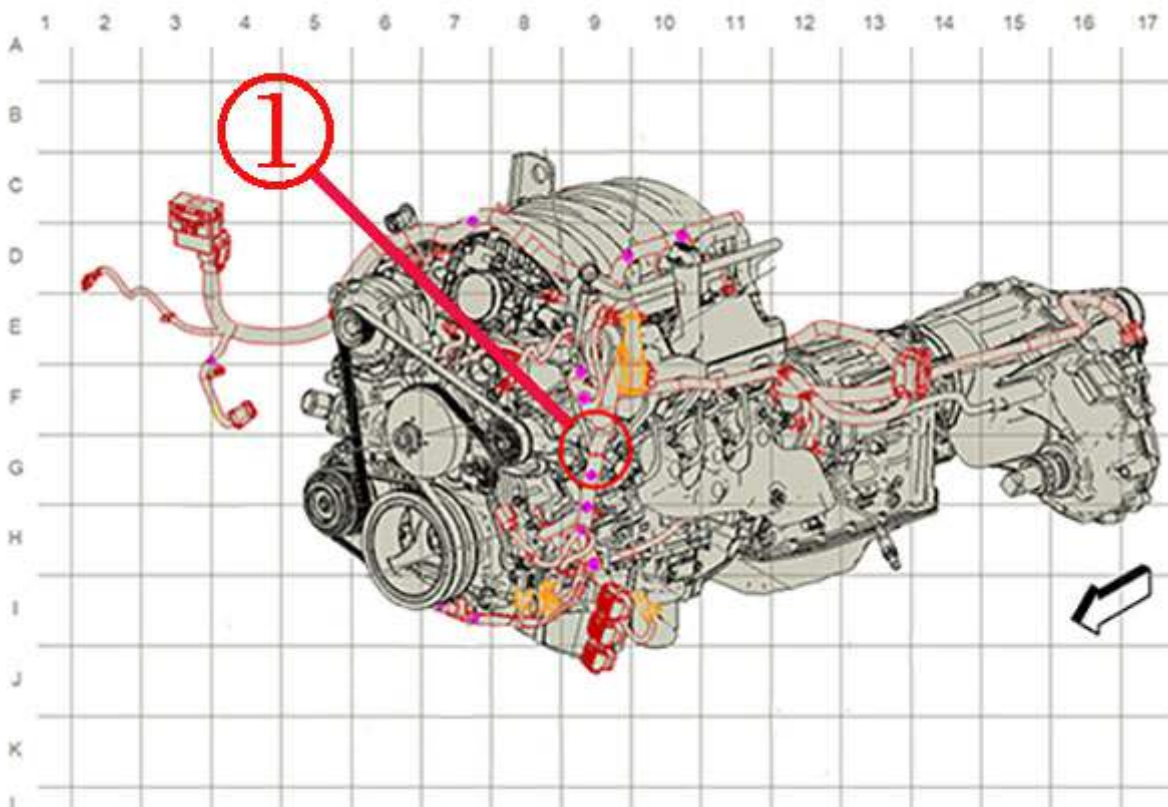
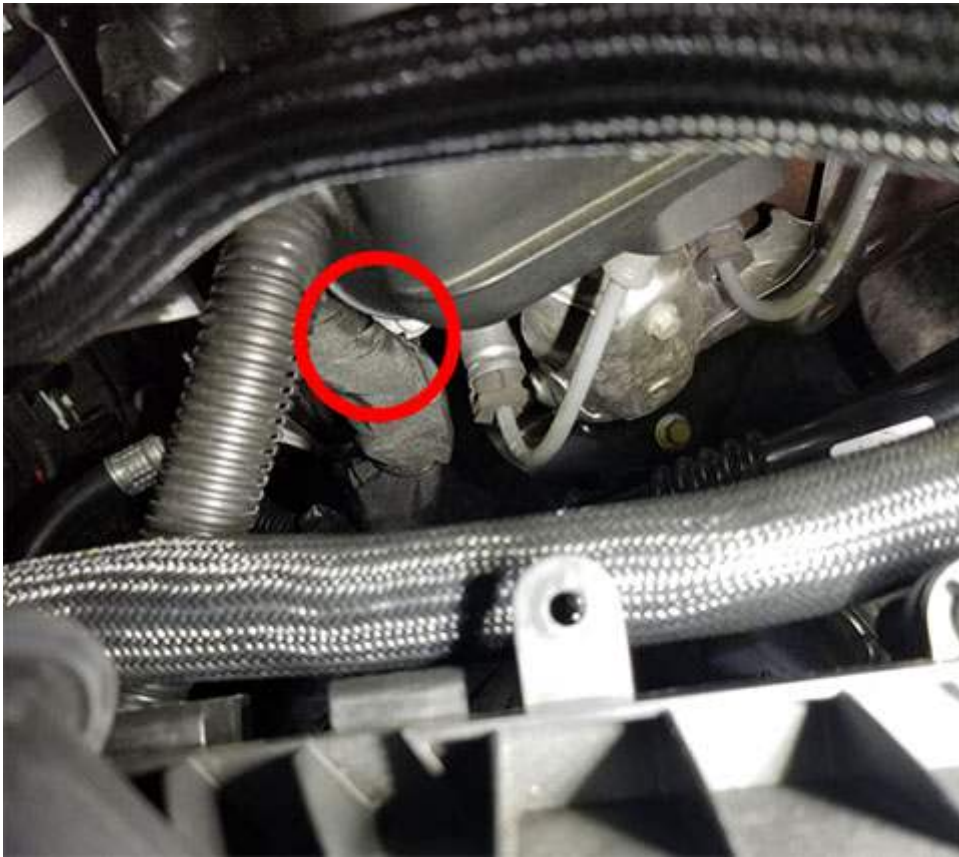
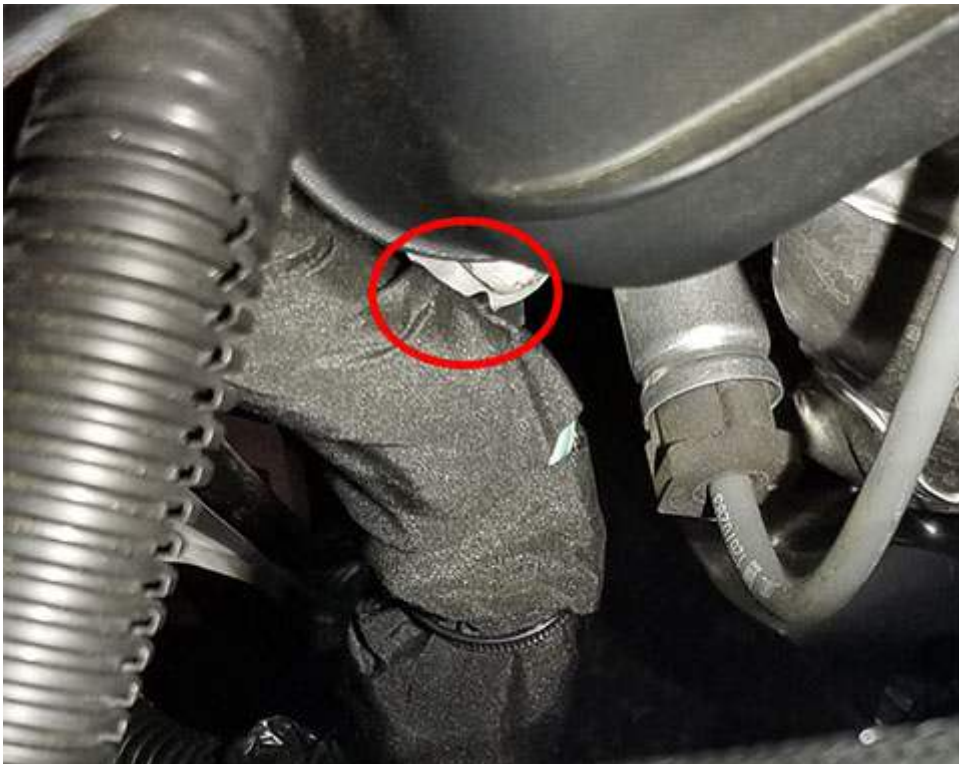
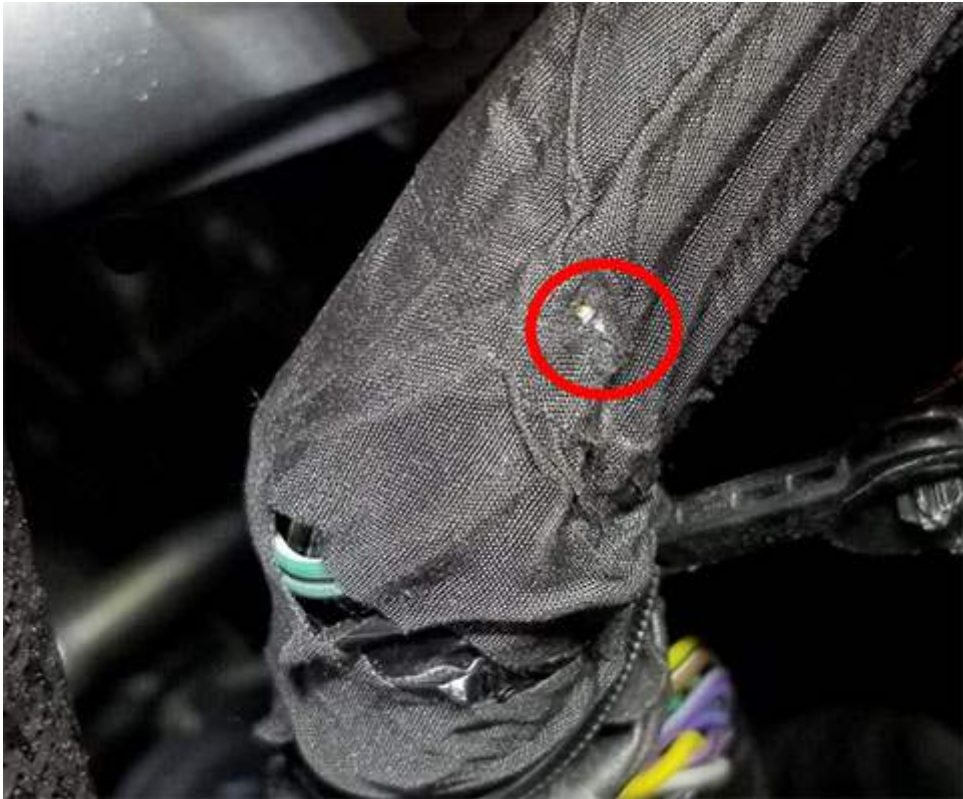
| Cause | These concerns could be caused by the engine wiring harness rubbing on the front corner of the left hand cylinder head (1) and shorting any number of circuits to ground, see pictures below. |

To correct this concern, repair the damaged wiring following the SI wire-to-wire repair procedures. Once repaired, protect and reposition the engine wiring harness to prevent future harness damage.
