**NUMBER:** 18-021-15 REV. E

Flash: 3.0L Powertrain Diagnostic And System Enhancements

2014 (DS) RAM 1500 Pickup

**NOTE: This bulletin applies to vehicles equipped with a 3.0L Diesel Engine (Sales Code EXF).**

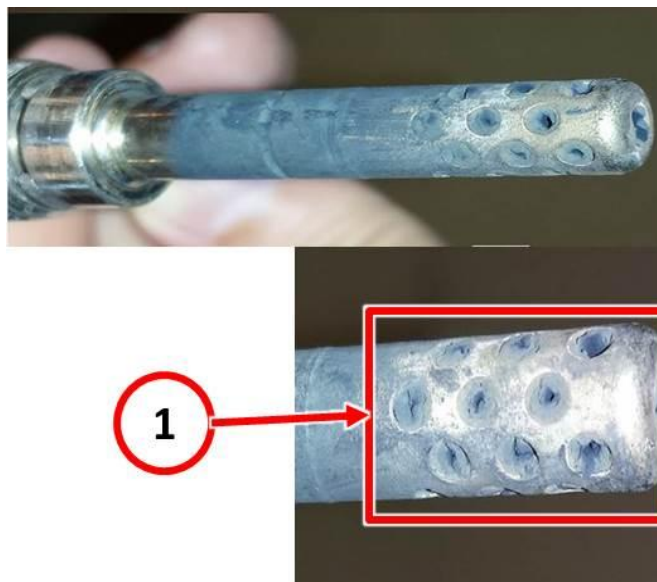
**Fig. 1 EGT Sensor Bank 1 Sensor 1**

11. Replace the O2 sensor. Refer to detailed repair procedures available in DealerCONNECT> TechCONNECT> Service Info Section 14 - Fuel System> Fuel Injection, Diesel> Sensor, Oxygen> Removal/Installation. Proceed to [Step #12](#).
12. Remove the EGT Sensor 1/2 located in the inlet of the Diesel Particulate Filter (DPF)/Diesel Oxidation Catalyst (DOC) assembly. Refer to detailed removal procedures available in DealerCONNECT> TechCONNECT> Service Info Section 11 - Exhaust System> Sensor, Exhaust Temperature> Removal> Exhaust Gas Temperature Sensor 1/2.
13. Inspect the sensor body and probe for any signs of damage or excessive soot. See ([Fig. 1](#)).

1 - Excessive soot blocking sensor ports

- 
14. Was excessive soot found on the sensor?
    - a. Yes>>> Proceed to [Step #15](#).
    - b. No>>> Proceed to [Step #16](#).
  15. Using shop air set to a maximum of 80 psi, clean all excessive soot from the sensor probe.
  16. Using a suitable multi-meter with appropriate test probes, test the resistance between the sensor connector terminals 1 and 2. With the sensor at room temperature, 65-75 °F (18-25 °C), the resistance should measure between 200 and 240 ohms.

17. Is the temperature sensor resistance within specifications?

- a. Yes>>> Install the original EGT sensor 1/2. Refer to detailed installation procedures available in DealerCONNECT> TechCONNECT> Service Info Section 11 - Exhaust System> Sensor, Exhaust Temperature> Installation> Exhaust Gas Temperature Sensor 1/2.
- b. No>>> Install a new EGT sensor 1/2. Refer to detailed installation procedures available in DealerCONNECT> TechCONNECT> Service Info Section 11 - Exhaust System> Sensor, Exhaust Temperature> Installation> Exhaust Gas Temperature Sensor 1/2.
