**NUMBER:** 18-023-15 REV.C

Flash: 3.0 L MIL Illumination Diagnostic and System Improvements

2014 (WK) Jeep Grand Cherokee

**NOTE: This bulletin applies to vehicles equipped with a 3.0L diesel engine (sales code EXF).**

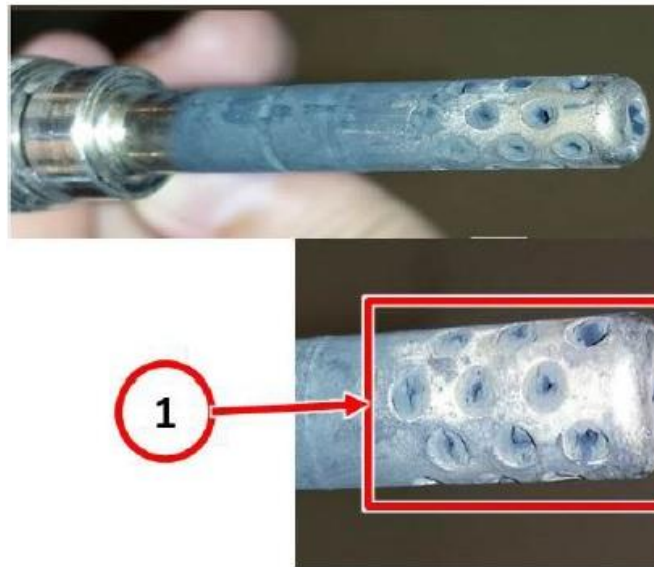
**Fig. 1 EGT Sensor Bank 1 Sensor 1**

11. Inspect the sensor body and probe for any signs of damage or excessive soot. See (Fig. 1).

1 - Excessive soot blocking sensor ports

- 
12. Was excessive soot found on the sensor?
- Yes>>> Proceed to [Step #13](#).
  - No>>> Proceed to [Step #14](#).
13. Using shop air set to a maximum of 80 psi, clean all excessive soot from the sensor probe.
