## M274 Check engine light, P052E71 Crankcase ventilation valve

| Topic number | LI01.20-P-076894 |
| Function group | 01.20 - Crankcase ventilation, cylinder head cover |
| Validity | Passenger car with engine M274 |

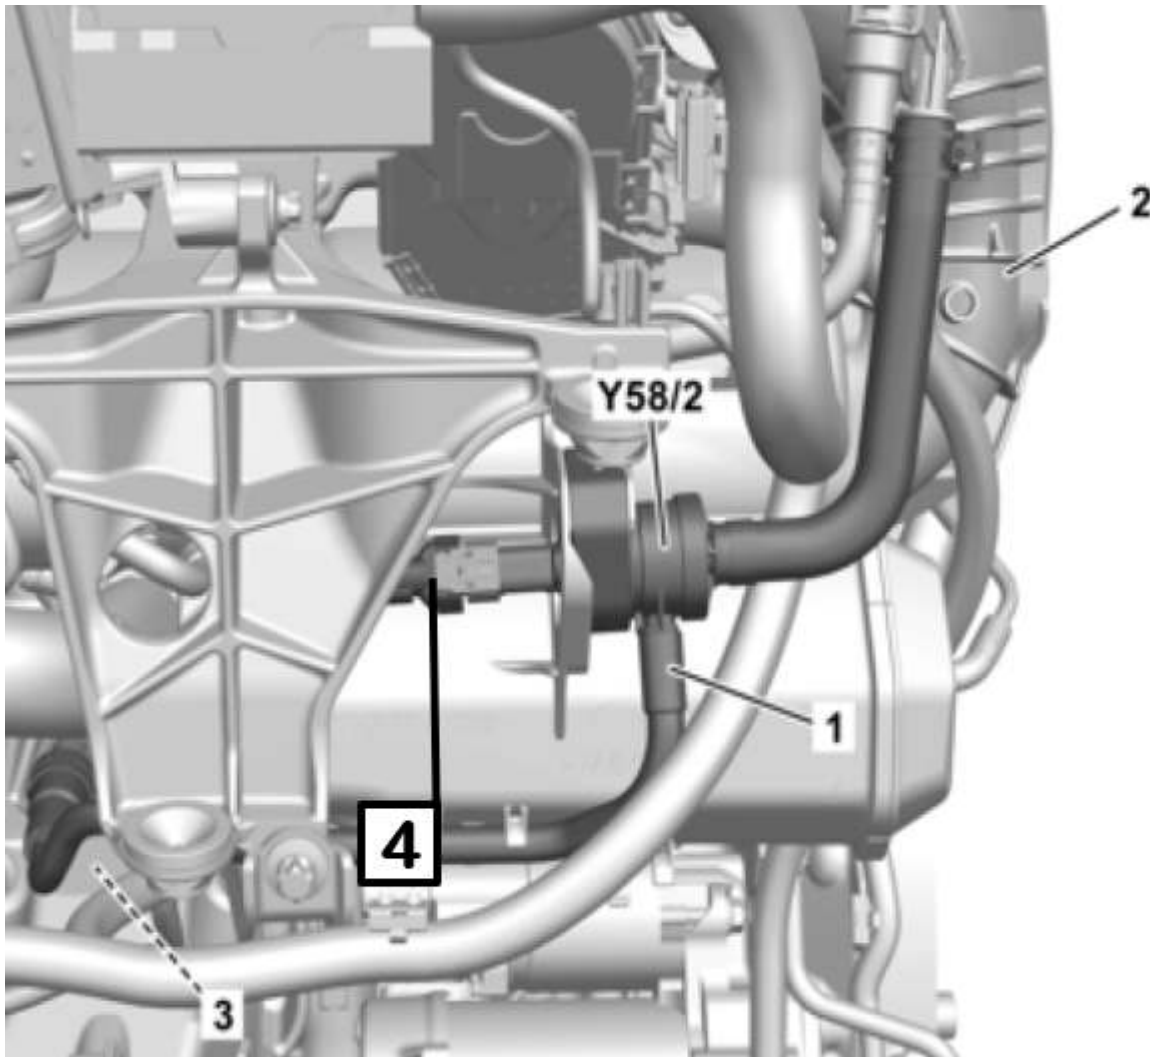
The partial-load ventilation valve (a part of the intake line assembly) may not work as intended.

- 1- Perform software update for N3/10 Engine control unit.
- 2- Remove upper engine cover.
- 3- Unclip ME-SFI control unit (N3/10) with bracket and place to one side with connected lines (see AR07.08-P-7013M-RD).
- 4- Release and disconnect electrical connector (4) of partial-load operation crankcase ventilation valve (Y58/2).

5- Fit cap A094 545 50 03 on electrical connector (4) of engine wiring harness partial load operation crankcase ventilation valve (Y58/2) and ensure correct seating on plug of electrical connector (4).

6- Strap down electrical line (4) of partial load operation crankcase ventilation system valve (Y58/2) at wiring harness. Ensure that electrical line (4) is routed free of tension.

7- Clip in ME-SFI[ ME] control unit (N3/10) with bracket, ensure control unit is correctly seated at attachment points.
