**Lack of Cooling Power or Air-Conditioning System Failure - Fault Memory Entry "B16A284" / "B16A384": Observe Procedure for Air Conditioning Testing (54/25)**

Model Line: **Taycan (Y1A / Y1B / Y1C)**

Model Year: **As of 2020**

Concerns: **Air-conditioning system**

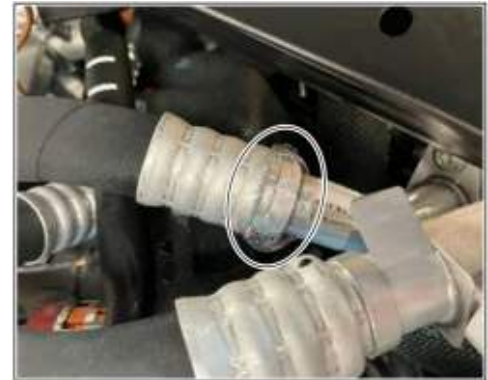
All vehicles are filled with the correct amount of refrigerant during production; therefore, an insufficient amount of refrigerant is due to a **leakage**.

Cause: Refrigerant leaks in the form of microleakages can occur on all refrigerant-carrying components of the air-conditioning system and may not be detectable with the air conditioning service unit.

*Example of a leak on pressing with alkali/soapy water*

Action: If there is a customer complaint, refill the refrigerant circuit, then **spray all refrigerant-carrying components of the air-conditioning system (lines incl. hoses, etc.) with alkali/soapy water** and check for microleakages.

**The leak test of the air-conditioning system must be carried out within the framework of this Technical Information using alkali/soapy water on all refrigerant-carrying components of the air-conditioning system. ⇒ Example of a leak on pressing with alkali/soapy water**

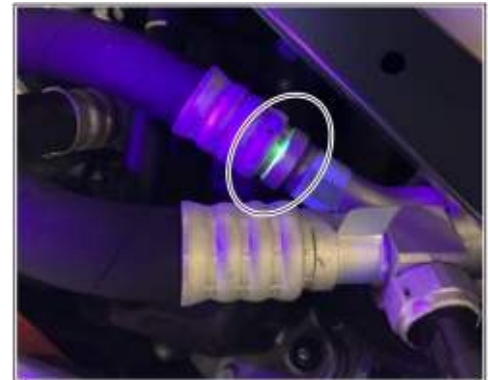
*Example of a leak on pressing with leak detection additive*

Please follow the correct sequence for this and do not  
⇒ Example of a leak on pressing with leak detection additive start immediately with the leak detection additives.
