**Intermittent Warning Message "Power Button Faulty - Service Required" in the Instrument Cluster/Fault Memory Entry "B143C29" in the Rear-End Electronics Control Unit (65/25)**

Model Line: **Taycan (Y1A/Y1B/Y1C)**

Model Year: **As of 2020 up to 2025**

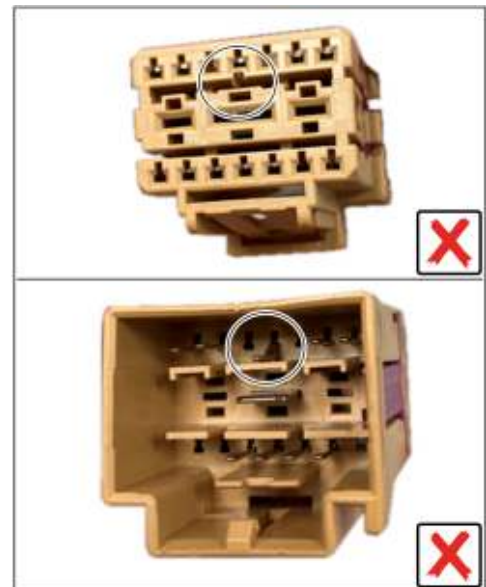
It is possible that pin 4 is bent at the electrical plug connection TCPR.1A1 (disconnection point) **between the dashboard and main wire harness.**

*Bent pin with damaged plug housing*

**Therefore, before replacing the start-stop switch, the electric plug connection must be checked for bent pins, reworked if necessary or replaced if damaged. ⇒ Bent pin with damaged plug housing**
