2021-2023MY  
Sorento (MQ4a)

257

## TECHNICAL SERVICE BULLETIN

ITM REPLACEMENT AND ECM & TCM  
LOGIC IMPROVEMENT (CA2508)

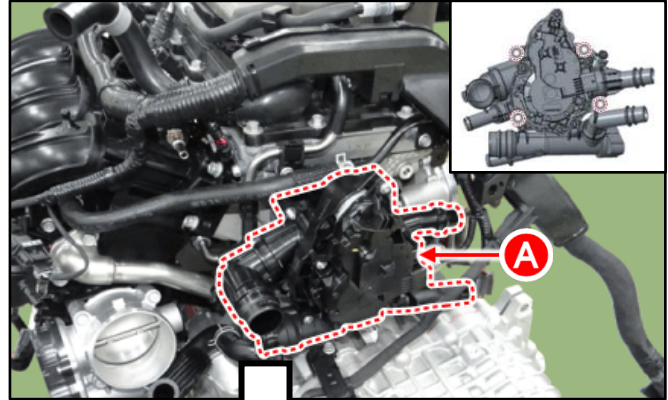
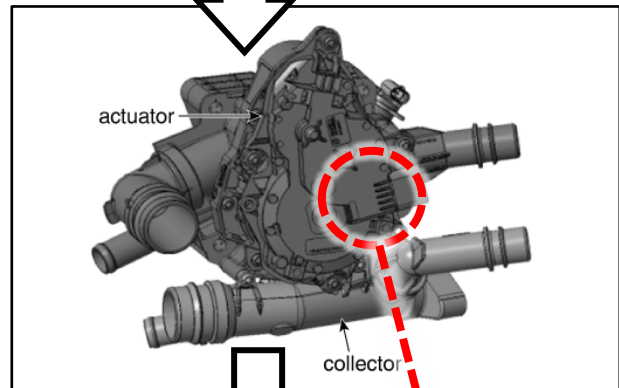
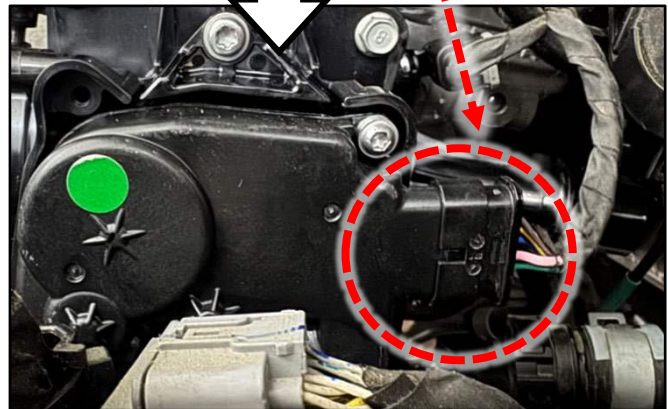
**Note:** The ITM connection orientation changes after replacing the new ITM part. The locking tab will face the engine.

Trying to make the connection on the new ITM in the same orientation as the original ITM may damage the connector pins/terminals.

2. Reinstall all removed parts in reverse order of removal.
