| ELE | 2025MY<br>EV6 (CVa) <u>and</u><br>2026<br>EV9 (MVa) |
| 409 | December 2025 |

## TECHNICAL SERVICE BULLETIN

### SERVICE ACTION: INTEGRATED CHARGE CONTROLLER UNIT REPLACEMENT (SA639)

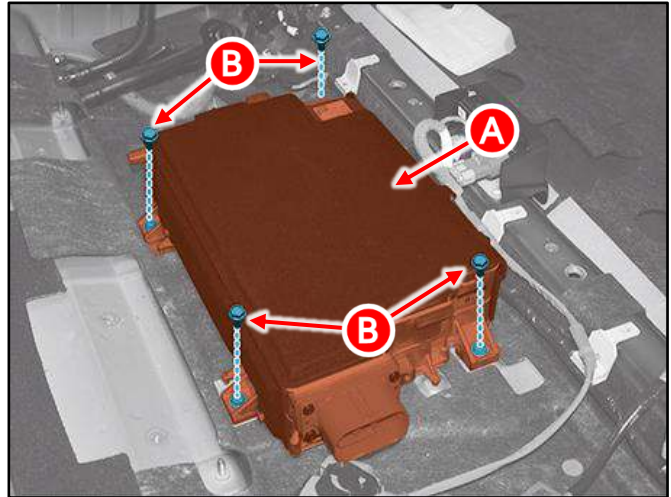
**Repair Procedure For EV6 (CVa):**

This bulletin provides instructions for replacing the Integrated Charge Controller Unit (ICCU) on certain 2025 model year EV6 (CVa) and 2026 EV9 (MVa) vehicles produced between February 21, 2025, and September 18, 2025. Affected vehicles may exhibit Diagnostic Trouble Code (DTC) P2E9092 related to the Battery Charger "A" Internal Power Supply, resulting in an inability to charge under Level 1 or Level 2 conditions. Follow the procedure in this bulletin to replace the ICCU on applicable vehicles. Before performing the repair, confirm that the vehicle is included in the affected VIN list.

1. Replace the ICCU (A) by referring to "High Voltage Charging System → Integrated Control Unit (ICCU) → Removal and Installation Repair procedures" in the applicable Shop Manual on KGIS.

Tightening torque for ICCU Case to Body  
Bolts (B): 14.5 - 17.3 lb.ft (19.6 - 23.5 N.m)
