## Technical Service Bulletin

**25-EM-007H**

**ITM THERMOSTAT SPRING INSTALLATION &  
ECU SOFTWARE UPDATE – DTC P218100**

**Description:** Some Elantra (CN7, CN7A), Kona (OS, SX2), and Sonata Hybrid (DN8 HEV) vehicles equipped with 2.0L engines may illuminate a warning lamp for DTC P218100 (Cooling System Performance) related to the Integrated Thermal-Management Module (ITM).

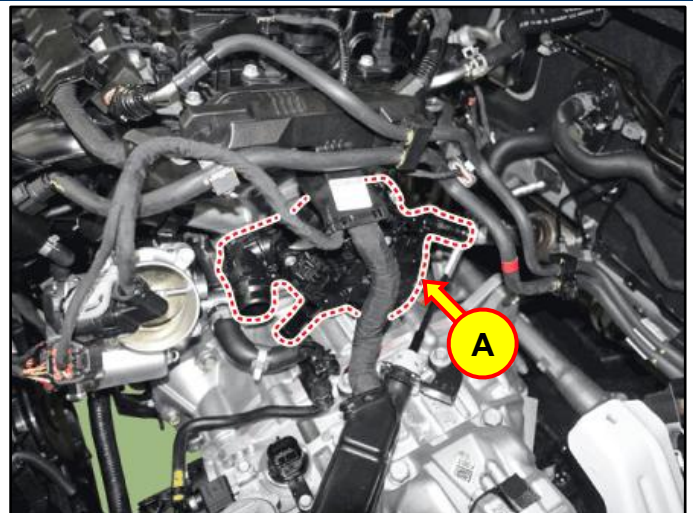
1. Remove the Integrated Thermal Management Module (ITM) (A).

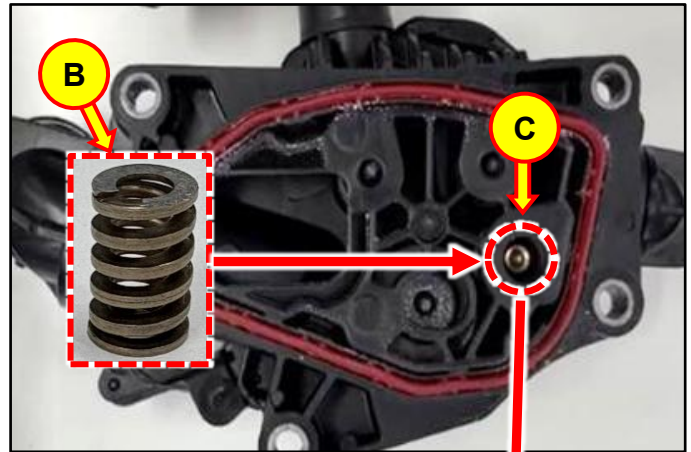
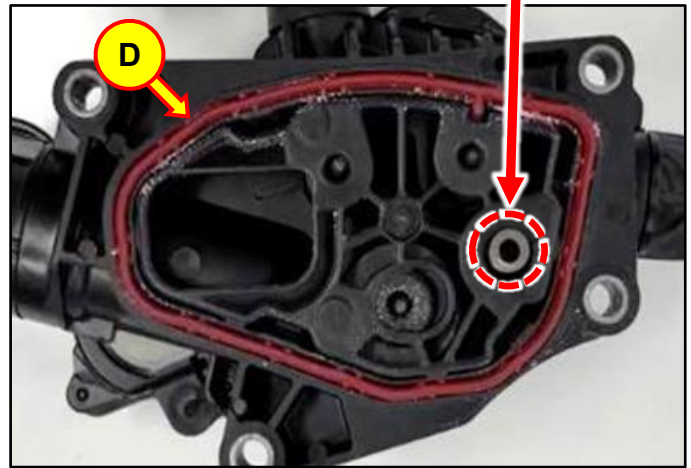
2. Insert the spring (B) into the ITM thermostat hole (C).
3. Install the new thermostat housing gasket (D) onto the ITM.

Ensure that the gasket is properly installed and pushed into the grooves of the ITM housing.

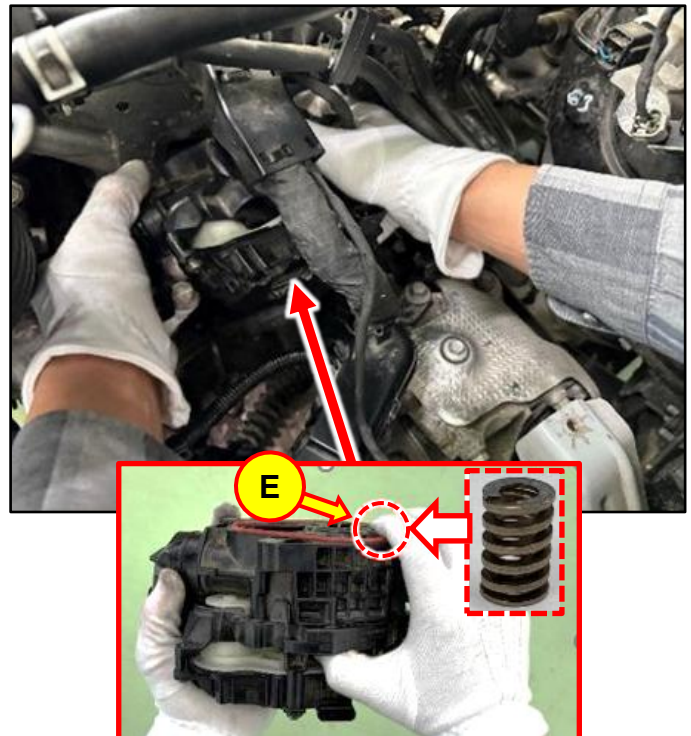
When installing the ITM assembly, hold the spring down with your finger as shown (E) to prevent the spring from falling out.
