# Technical Service Bulletin

| <b>Topic</b> | DTC P14AB00 and/or other related exhaust flap DTC's - Warning lamp evident within the DIP |
| <b>Brand</b> | Bentley |
| <b>Transaction No.</b> | 2055664/3 |

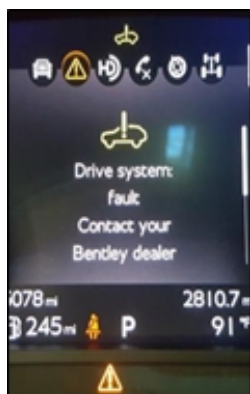
- Referring to Figure 1 - Warning lamp illuminated within the Drivers Information Panel (DIP)

- DTC P14AB00 and various DTC's evident within the Engine control modules 1 and/or 2 regarding exhaust control unit mechanical malfunctions
- Abnormal noises from the exhaust system
- This issue is applicable to both Standard and Sports exhaust systems

- The warning lamp and DTC's can be triggered by non-operation of the exhaust flap control unit/s

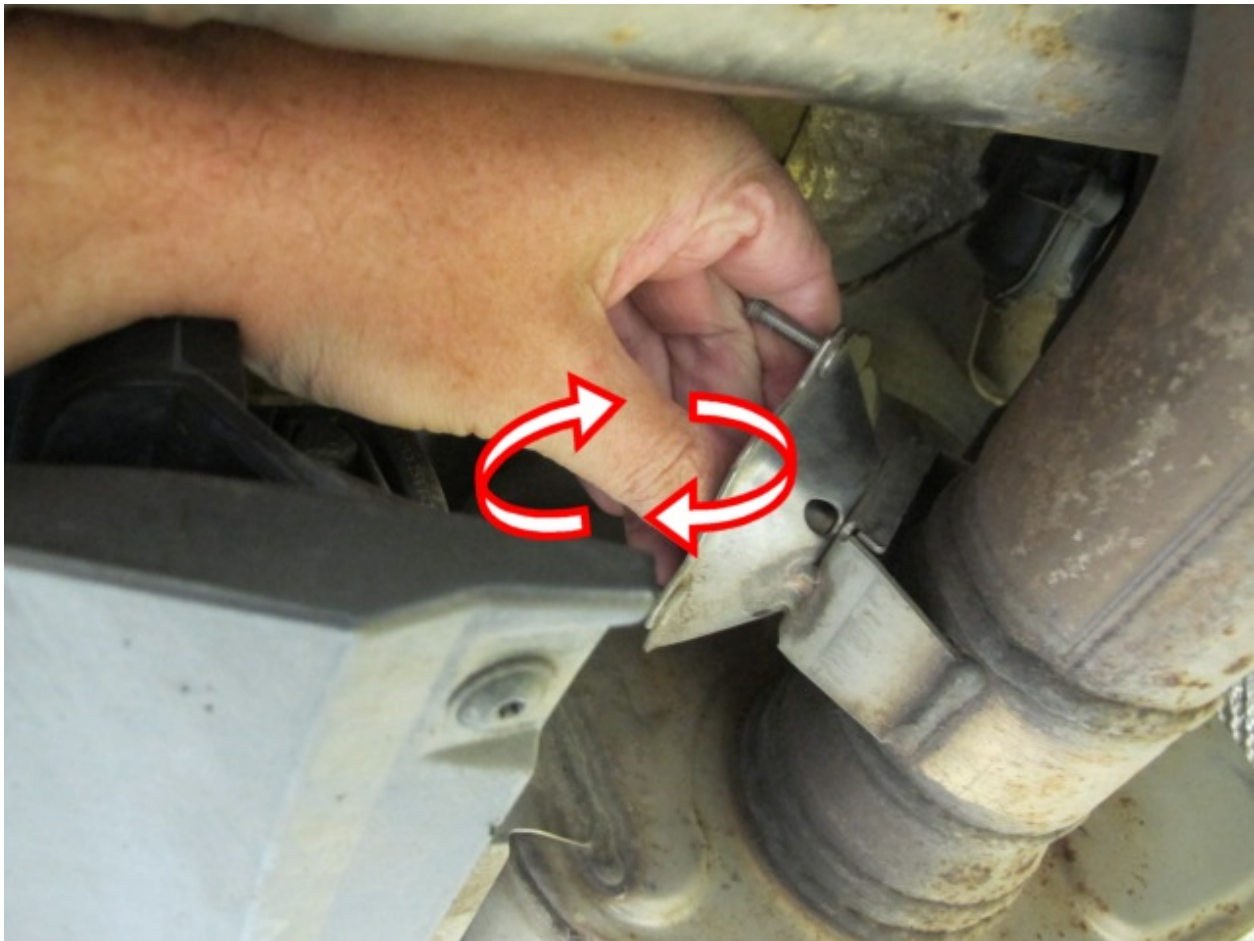
Figure 1

- Check and confirm the exhaust flap can be rotated by hand (clockwise and anti-clockwise) without the control unit fitted (Figure 1)

- Should no issue be evident with the exhaust flap and it can be freely rotated by hand - Replace the defective exhaust flap control unit Refer to Rep.Gr 26
