# Technical Service Bulletin

| Topic | DTC P096C00 and / or P096F00 evident within the Engine Control Module |
| Brand | Bentley |

## Bentayga Series - V8 Kovomo

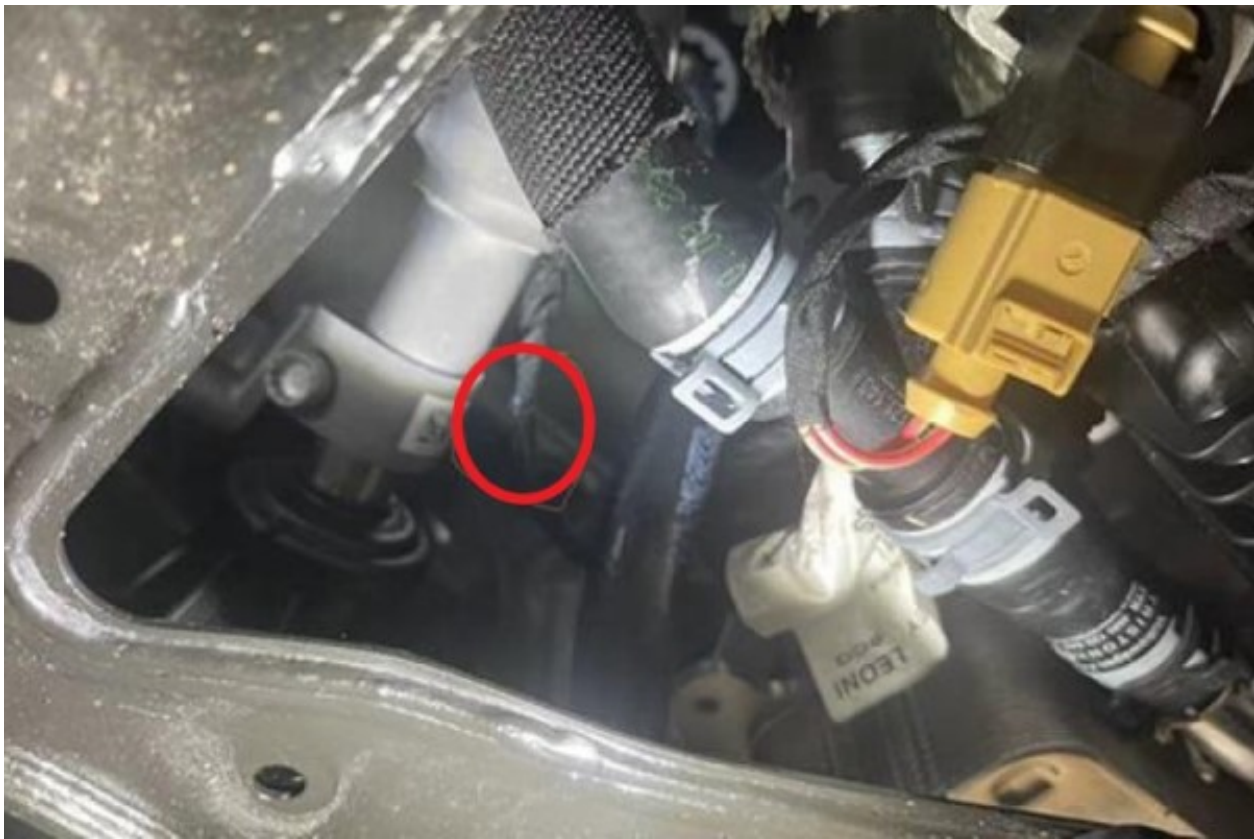
Figure1

- 1) Referring to the applicable wiring diagram - Conduct an electrical integrity check of the N509 gearbox cooling valve circuit
- 2) Referring to Figures 1, 2 and 3 - Conduct a visual inspection to confirm if the harness shown (CIRCLE) has any damage relating to contact with the steering shaft .

In the event the issue is as described the operative must conduct the remaining instructions (step 3 and 4) to completion and repair the damaged cable(s)

3) Referring to Rep.Gr 97 - Wiring harness repairs - Repair the damaged wiring using the VAS 1978B wiring repair kit
