## TECHNICAL SERVICE BULLETIN

### Incorrectly Illuminated Powertrain Malfunction (Wrench) Indicator With DTC P1706 Stored In The (SOBDMC) And A "Shift System Fault" Message Displayed In The Message Center

**25-2628**

| <b>Ford</b><br>2025 Maverick | Engine: 2.5L HEV<br>Built on or before 02-May-2025 |

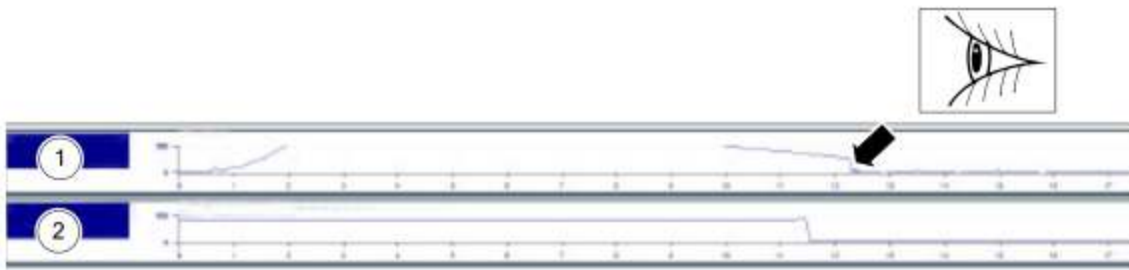
18. Select the Playback tab.
19. Place the cursor over the last non-zero value of the M\_SPEED chart and left mouse click on it. The RPM value should now be displayed to the left of the graph.
20. Using either the Snipping Tool or pressing the "prt sc" button on the keyboard, capture and save a screenshot of the entire graph, including the M\_SPEED value.
21. Perform the test a second time. (Repeating Steps 14-20)
22. Review both recordings. Did the M\_Speed PID show a sudden drop from above 80 RPM down to 0 RPM as shown in Figure 1 in both tests?

- (1). Yes - clear DTCs, repair is complete.
- (2). No - perform a Self-Test. If DTCs P1706 returns, refer to WSM, Section 307-01A for normal diagnostics. Repair as necessary outside of this article.
