# Technical Service Bulletin

| <b>Topic</b> | Dynamic ride system warning visible - DTC P0B2500 logged within address 0021 (Battery Energy Control Module 2) |
| <b>Transaction No.</b> | 2068946/11 |
| <b>Release date</b> | Dec 10, 2025 |

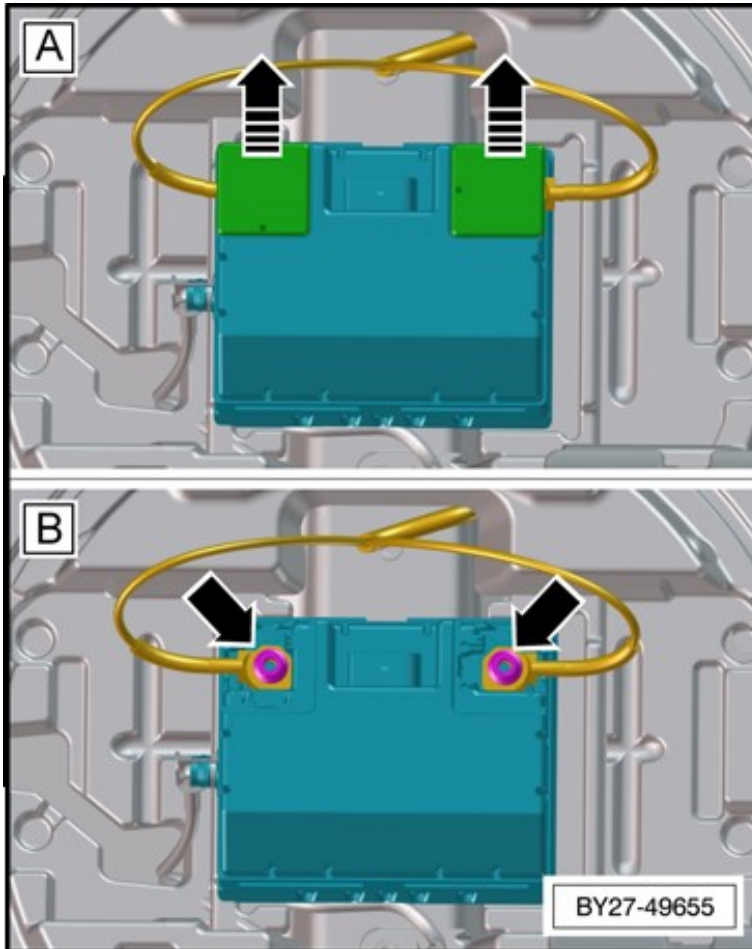
Figure 1

DTC P0B2500 - Hybrid/EV Battery "A" Voltage low is stored within address 21- Battery Energy Control Module 2

Possible internal fault with the super capacitor

2) Referring to Rep.Gr 27 - Check the security of the super capacitor positive and negative terminals (Figure 1) as follows:

- Remove the caps (A) from the terminals
- Check the security of the positive and negative terminals (B) are as described within Rep.Gr 27

- In the event that one or both terminals were not tightened to the correct torque as Rep.Gr 27, the operative must tighten the terminal(s) to the correct torque as detailed within Rep.Gr 27 - Super capacitor

In the event one or both terminals required tightening to the correct torque (found to be not initially secure) the operative must feedback the findings via DISS
