## Technical Service Bulletin

Transaction No.: **2078134/2**

93 Q4 e-tron - electric drive system warning lamp lights up / event memory entry:  
P0BBD00 in 008C

Release date: Dec 4, 2025

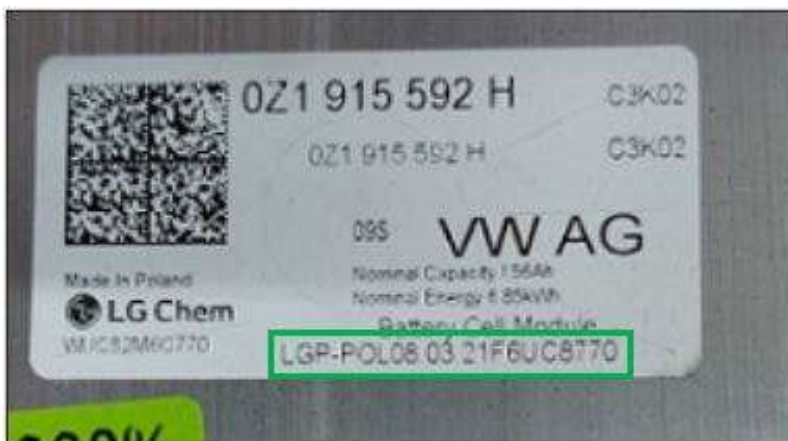
- Remove and open the high-voltage battery as per the Workshop Manual.
- Check the manufacturing date on type plate of the battery module to be renewed (see Figure 1):

- The consecutive production number (see Figure 1, highlighted in green) also includes the manufacturing date of the battery module. The manufacturing date of the battery module from the example (see image 1, highlighted green): LGP-POL **08.03.21** F6CUC8770 would therefore be **03/08/2021**.

**Figure 1.** Example image of a battery module type plate with production date: 08 03 21 (= 08.03.2021).

- If a battery module with a manufacturing date **prior to 12/04/2023** is installed **and** has one of the following part numbers: 0Z1.915.592.G, 0Z1.915.592.H, 0Z1.915.592.J, 0Z1.915.599.G, 0Z1.915.599.H, 0Z1.915.599.J, 0Z1.915.599.P, the battery module must be replaced according to the Workshop Manual/parts catalogue.

- If a battery module with a manufacturing date **from 12/04/2023 onwards** is installed, a *technical repair query* must be created.
