# Technical Service Bulletin

| Topic | Engine Overheating - Warning in the DIP V8 Kovomo |
| Brand | Bentley |
| Transaction No. | 2061369/11 |

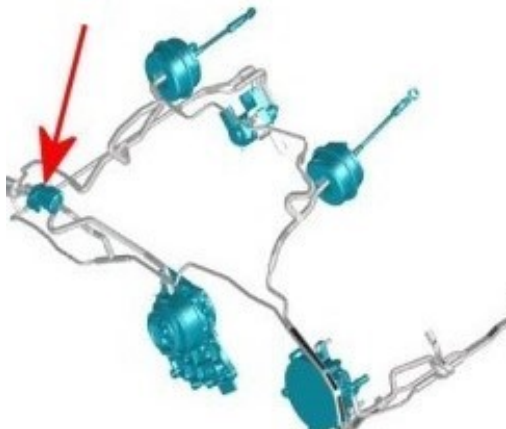
To allow the engine coolant to heat as quickly as possible (from cold start) coolant delivery from the mechanical coolant pump is interrupted by switch valve N649

Figure 1 - Bentayga

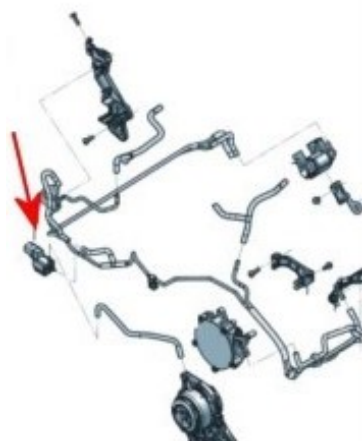
Figure 2 - New Continental GT/ GTC and Flying Spur

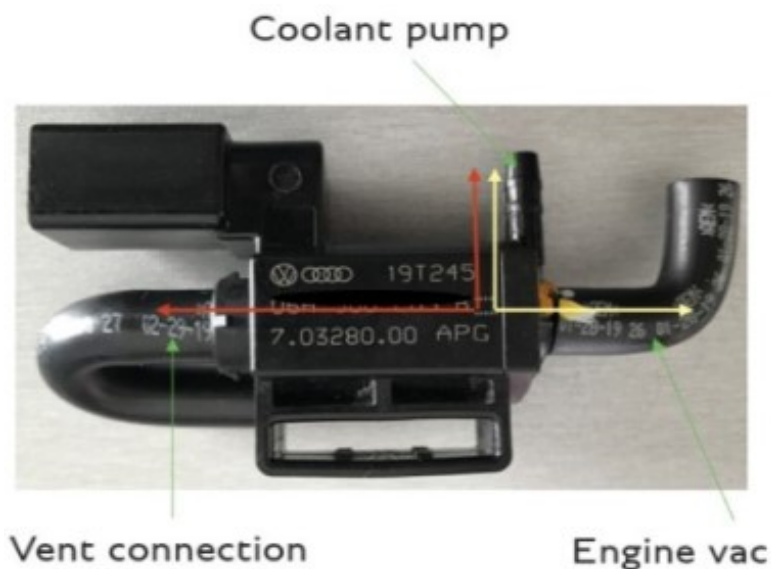
Figure 3

The correct operation of N649 (Figure 3) is as follows

Un-energised state (Ignition off) - Coolant pump connected to vent connection (red arrows)

Energised state (Ignition on) - Engine vacuum connection to coolant pump (yellow arrows)

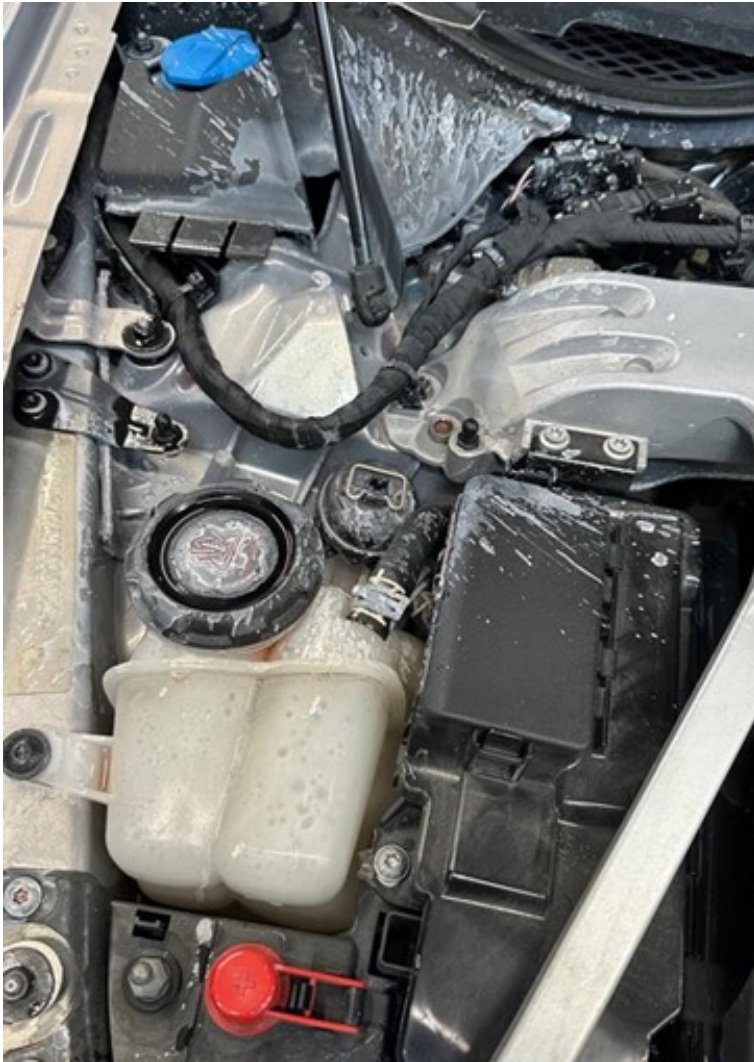
Figure 4

When inspecting the engine bay coolant residue can sometimes be seen around the reservoir when the engine has overheated (figure 4).

If this condition is found, the coolant may also be below the minimum level.

**If coolant residue is found in the engine bay, please raise a full technical DISS query and attach a photograph of the coolant residue. If the coolant level is below the minimum level please also attach photographic evidence of this.**
