# Technical Service Bulletin

| Topic | HVAC failing to cool DTC B16A1F0 in diagnostic address 00C5 Bentayga Series (Hybrid) 23MY - 25MY |

**2071190/3**

HVAC failing to cool | DTC B16A1F0 in diagnostic address 00C5 | Bentayga Series (Hybrid) | 23MY - 25MY

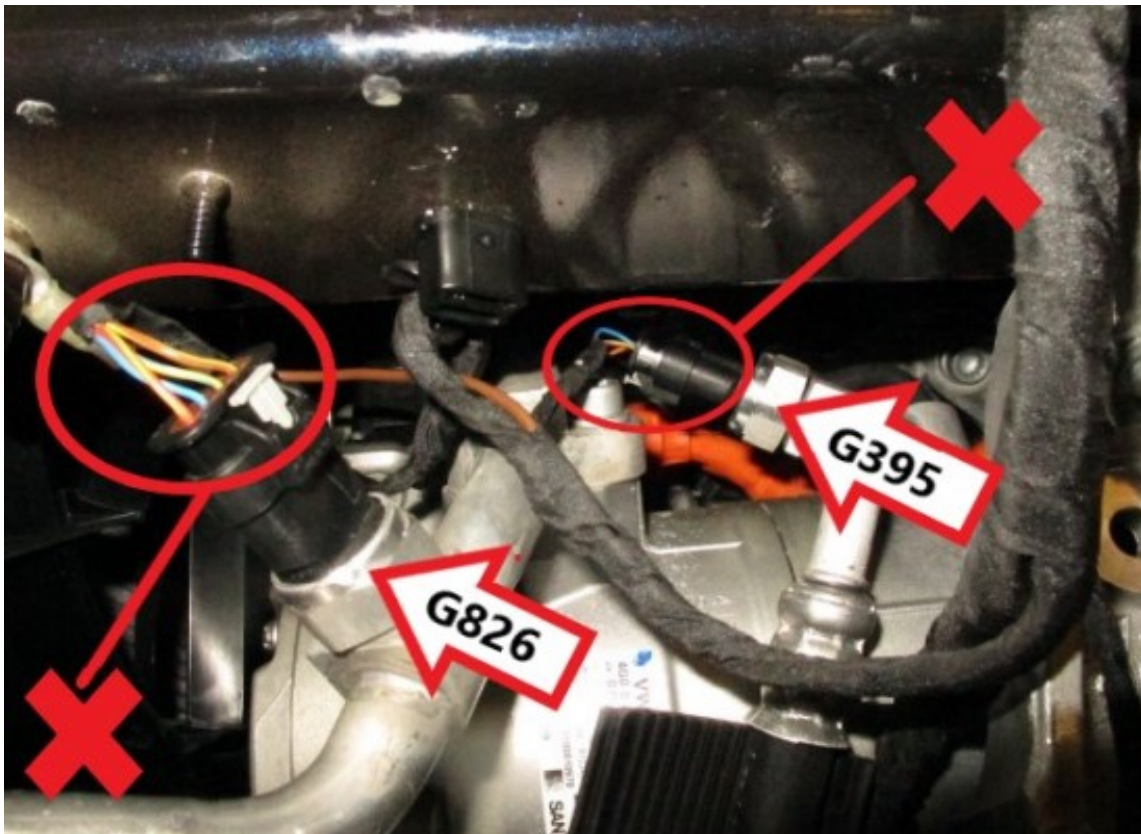
- 1) Referring to Rep.Gr 44 - Remove the left hand front wheel
- 2) Referring to Rep.Gr 66 - Remove the left hand front foremost wheel arch liner
- 3) Remove (x3) speaker box fixings (5Nm)
  - Disconnect the speaker box electrical connector
  - Remove the speaker box
- 4) Access can now be gained to the required connector plugs - Figure 1 shows G826 and G395 with the connector plugs fitted incorrectly
  - Low pressure sender G826 connector plug with 4 wires **(Incorrect)**
  - High pressure sender G395 connector plug with 3 wires **(Incorrect)**

In the event the pressure sender connector plugs are fitted incorrectly the plugs should be disconnected and refitted correctly as shown in Figures 2 and 3

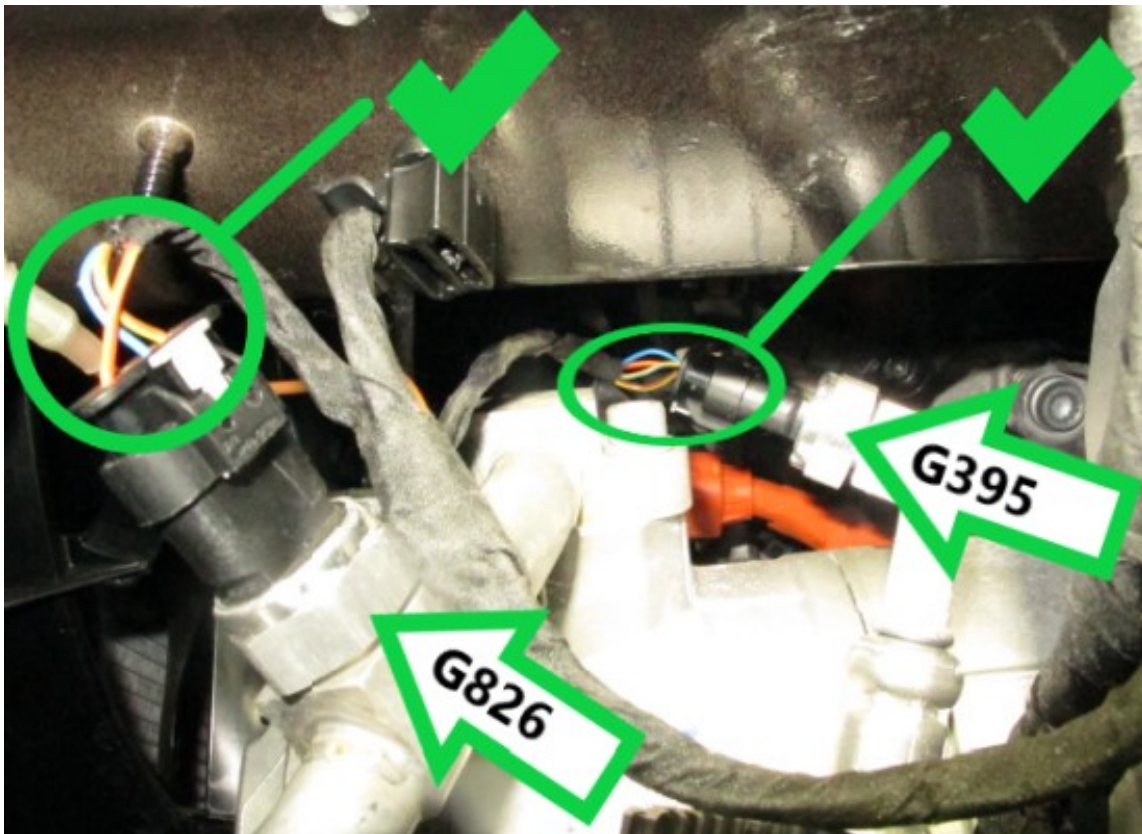
- Figure 2 shows G826 and G395 connector plugs fitted correctly
- Low pressure sender G826 connector plug with 3 wires (Correct)
- High pressure sender G395 connector plug with 4 wires (Correct)

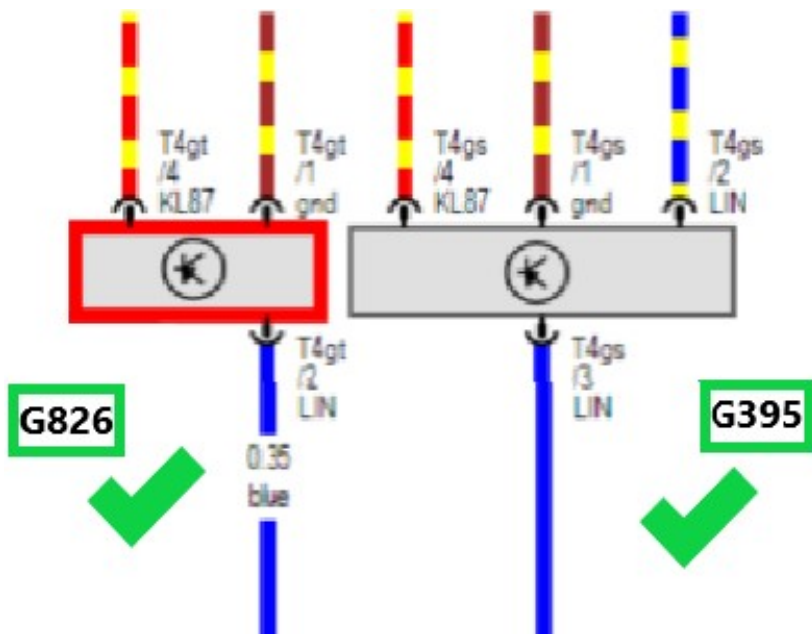
Hint: Figure 3 shows G826 and G395 as per the applicable Current Flow Diagram (Correct)
