| REFERENCE: | TSB: 08-011-26<br>GROUP: 08 - Electrical | Date: | January 15, 2026 | REVISION: | 08-286-25 |
| VEHICLES AFFECTED: | 2025 (WL) Jeep Grand Cherokee / Grand Cherokee L<br>This bulletin applies to vehicles **built on or before July 21, 2025 (MDH 0721XX)** equipped with a Global Telematics Box Module (Sales Code RDG). | | | MARKET APPLICABILITY:<br><div><input checked="" type="checkbox"/> NA<input type="checkbox"/> MEA<br/><input type="checkbox"/> SA<input type="checkbox"/> IAP<br/><input type="checkbox"/> EE<input type="checkbox"/> CH</div><br>NOTE: This bulletin applies to the North America market. | |
| CAUSE: | TBM Software | | | | |

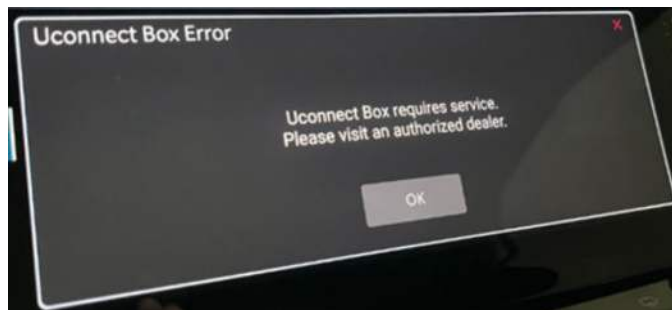
**Fig. 1**

**\*\*Uconnect Box Requires Service\*\***

**NOTE:** This message can be triggered by different reasons. For an issue on a new vehicle recently switched to customer mode, please follow the New Vehicle Preparation procedure to resolve the issue. For the customer vehicle with intermittent concerns, please check the TBM, antenna and instrument panel harness connections.

This bulletin involves reprogramming the TBM with the latest available software.

1. Reprogram the TBM with the latest software. If issues arise when flashing a module using the wiTECH Diagnostic Application, please submit a ticket to the Helpdesk. The helpdesk can be found within the Help menu.
2. Clear all DTCs that may have been set in any module due to reprogramming. The wiTECH application will automatically present all DTCs after the flash and allow them to be cleared.
