GENERAL MOTORS  
DCS 7420  
URGENT - DISTRIBUTE IMMEDIATELY

Subject: N252524761 - Service Update  
Fuel Pump DTCs P228C, P0089, and P00C6

Models: 2023 Chevrolet Equinox  
2023 GMC Terrain

### N252524761 Fuel Pump DTCs P228C, P0089, and P00C6

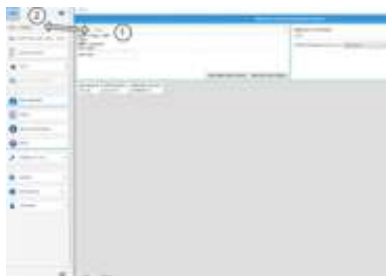
7001095

**IMPORTANT:** The service technician always needs to verify that the VIN displayed in the TLC left side drop down menu (1) and the top center window (2) match the VIN plate of the vehicle to be programmed prior to using Service Programming System 2 (SPS2) for programming or reprogramming a module.

1. Reprogram the Engine Control Module. Refer to *Engine Control Module: Programming and Setup* in SI. Carefully read the programming and setup document for further instruction.

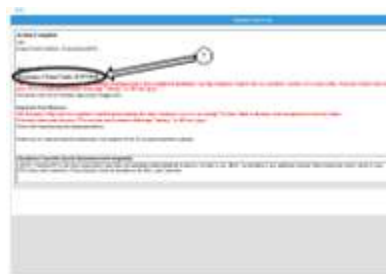
7001097

**Important:** To avoid warranty transaction rejections, you **MUST** record the warranty claim code provided on the Warranty Claim Code (WCC) screen shown above on the job card. Refer to callout 1 above for the location of the WCC on the screen.

2. Record SPS Warranty Claim Code on job card for warranty transaction submission. Refer to *25-NA-281 Information on SPS Warranty Claim Code Submission and Retrieval* in SI.
