## Technical Service Bulletin

| <b>Topic</b> | Asterix check for My Bentley error - DTC U163D00 evident in 005F |
| <b>Transaction No.</b> | 2080195/1 |

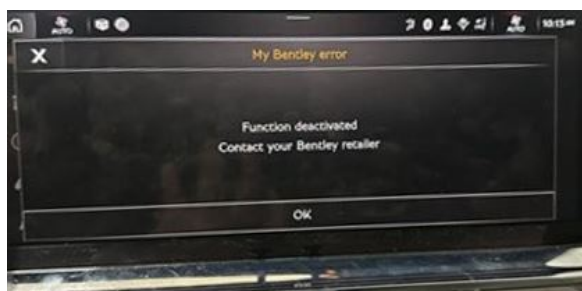
Customers experiencing a “My Bentley error” on the vehicle MIB, and are unable to use any App studio features, as per the examples in figure 1 and 2 below.

Figure 1. *My Bentley error*

Customers may see a “My Bentley error” on the MIB when the 5F control unit (MMI) fails to communicate with the Asterix App Studio plug-in on 25MY vehicles. This means that the customer will be unable to use the Asterix system. To resolve this, an Asterix check and further troubleshooting is required. Please refer to the measure section of this TPI for next steps.

1. Perform a hard reset of the MMI by pressing and holding the volume button on the switch pack for 30~seconds until you see the Bentley logo re-appear on the display.
2. Check the MIB display to see what state the MIB is in, it will either be in normal operating mode or fallback mode, see figure 3 and 4 below.

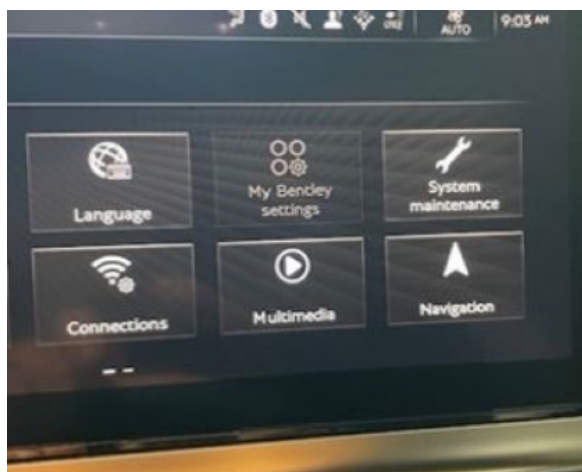
Figure 2. *My Bentley settings unavailable*

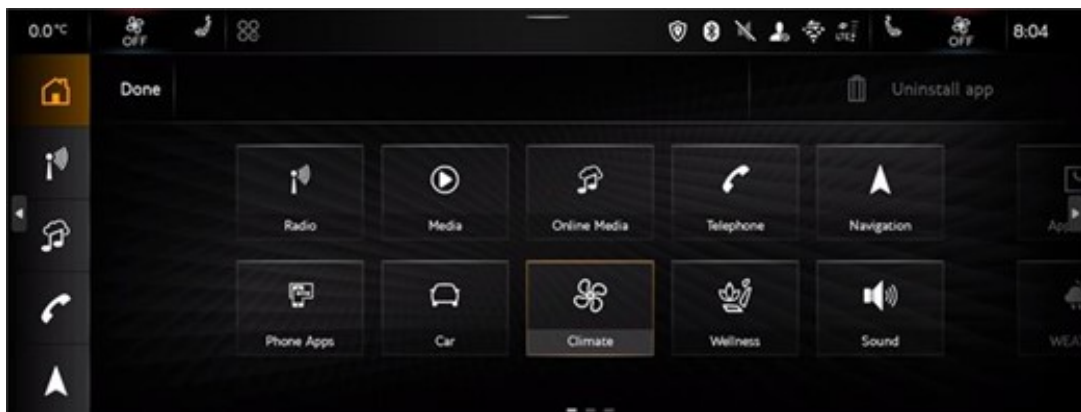
**Figure 3.** The MIB is in normal operating mode if the ambient temperature is displayed in the upper-left corner of the screen. Please note this will appear on the right hand side on right hand drive vehicles.

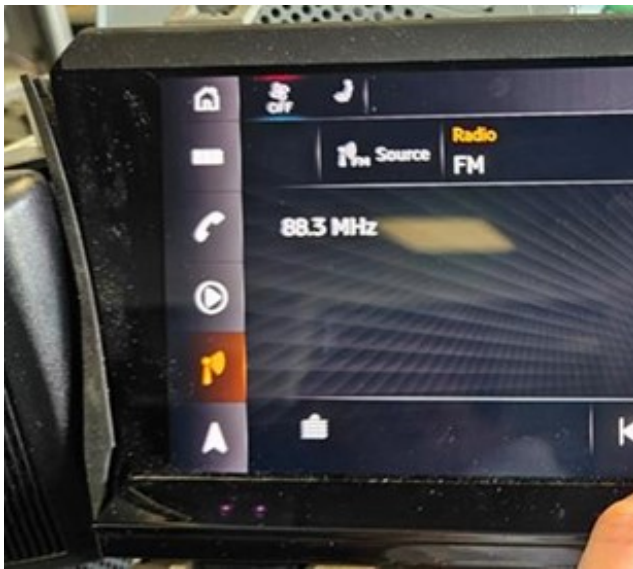
**Figure 4.** The MIB is in fallback mode if the ambient temperature is not displayed in the upper-left corner of the screen. Please note this will appear on the right hand side on right hand drive vehicles.

3. If the MIB is still in fallback mode (figure 4) perform a battery pull (terminal 30 fuse reset).

Disconnect the fuse for 10 seconds.

4. If the MIB state remains unchanged and still in fallback mode. Check wiring and connections

Inspect all wiring and connectors into the Asterix module for faults or loose connections.

5. Unplug the Asterix module

Leave it disconnected for 5 minutes, then reconnect and perform the hard reset from step 1.

6. Replace the Asterix module only if steps 1–5 fail and the MIB remains in fallback mode.
