# Technical Service Bulletin

| Topic | Drive System Fault in Kombi with DTC P0C5100 present Continental GT/GTC/Flying Spur 25MY |
| Brand | Bentley |
| Transaction No. | 2080242/1 |

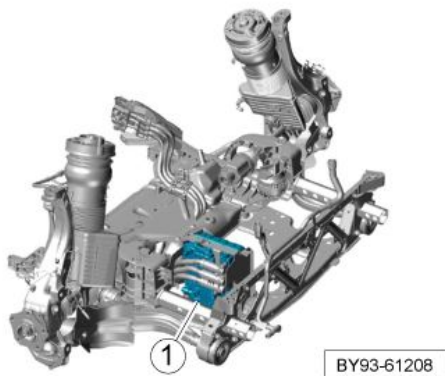
The electric drive control unit ( DC/AC converter for drive motor -A37- ) -1- is located on the right hand side of the engine.

## 2. Inspect wiring harness and connector terminals at the transmission sensor and Power Electronics (A37)

Check T8aa (8-pin connector, black), TMR (Coupling point in engine compartment, right), and T32am (32-pin connector, black) for:

- Physical damage (broken housing, bent pins, cracked insulation)
- Pin drag (verify terminal tension using correct test tool)
- Corrosion or contamination (look for rust, green deposits, dirt, oil, moisture)

To access the transmission sensor and Power Electronics (A37), follow the instructions below:

- Position the vehicle on a ramp, refer to ElsaPro Booklet 404
- De-energise the HV system, refer to ElsaPro Repair Group 93
- Disconnect the 12V battery, refer to ElsaPro Repair Group 27
- Remove the right hand front wheel, refer to ElsaPro Repair Group 44
- Remove the front right hand wheelarch liners, refer to ElsaPro Repair Group 66.
