# Service Bulletin

Bulletin No.: PIC6603A

**Subject: Diagnostic Tip: Service Headlamp Message - C103D sym28**

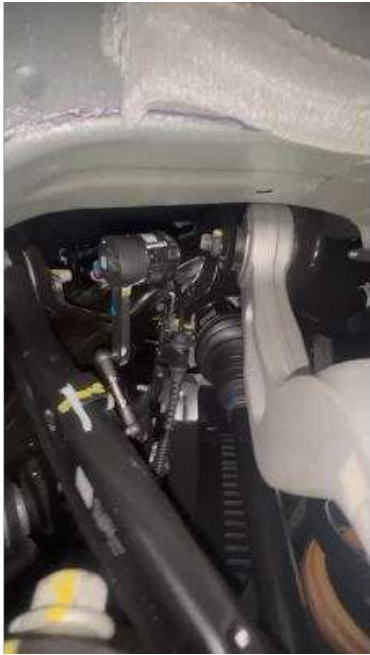
6888102

If scan tool data shows that this position to be less than 10%, with the vehicle parked on level ground, inspect the B152R leveling sensor arm for being mis-positioned, damaged or disconnected.

See example of a mis-positioned leveling sensor arm below.

If the sensor is mis-positioned, re-position sensor.

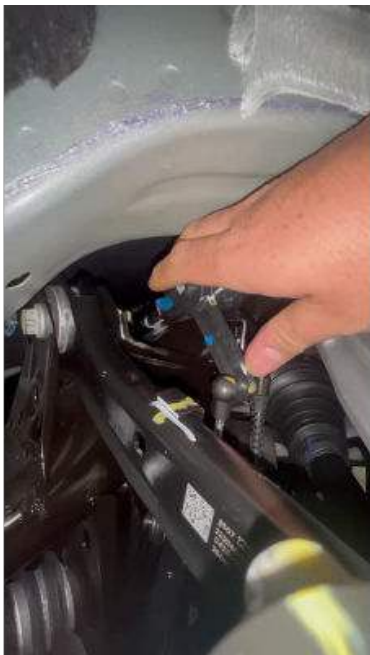
6907159

**Note:** Illustration below shows the correct orientation of the level sensor arm.
