# Service Bulletin

Bulletin No.: PIP5921B

**Subject: Diagnostic Tip: Possible No Start, Engine Noise Or SES Lamp with DTC P0011 P0016 Current Or History**

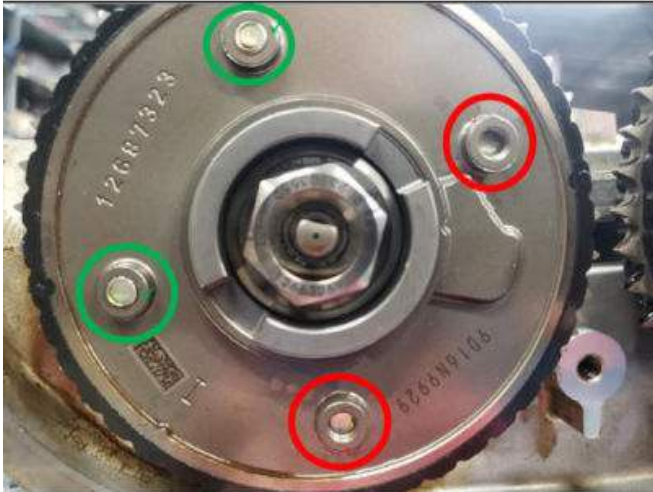
6340517

Picture below showing front side of Intake Cam Actuator. Circled in green and red are the actuator screws.

**Note:** Circled in red the threaded portion of the screws are below the surface indicating these are loose and have likely contacted the Cam Carrier face.

**Note:** If there are no signs of damage to the Cam Carrier face from the Intake Actuator screws then replace the Intake Cam Actuator using the latest Service Information.

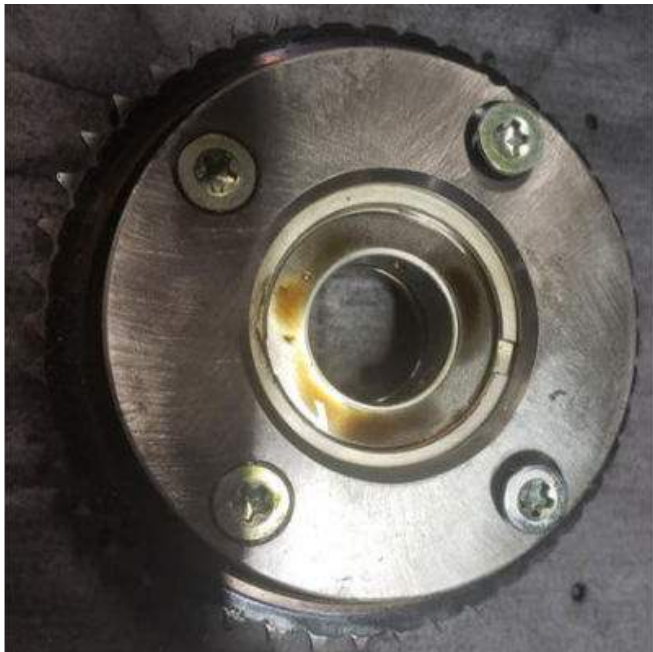
6340515

Back side of Intake Cam Actuator

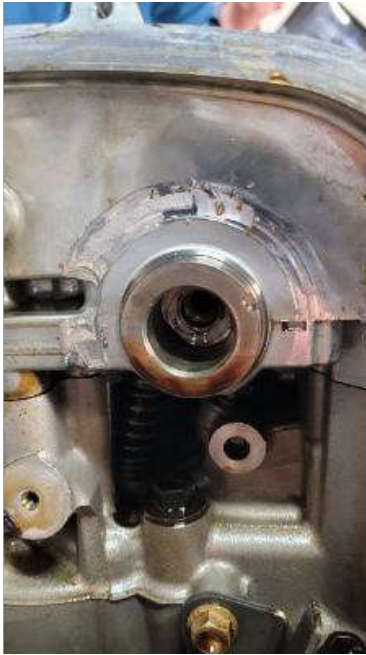
6331433

Picture below showing damage done to front face of Cam Carrier when the Intake Cam Actuator cover plate screws come loose and make contact.

If the Cam Carrier face has been damaged from an Intake Cam Actuator cover plate screw backing out then replacement of the engine assembly and turbocharger will be recommended due to metal debris in the engine from Cam Carrier face.

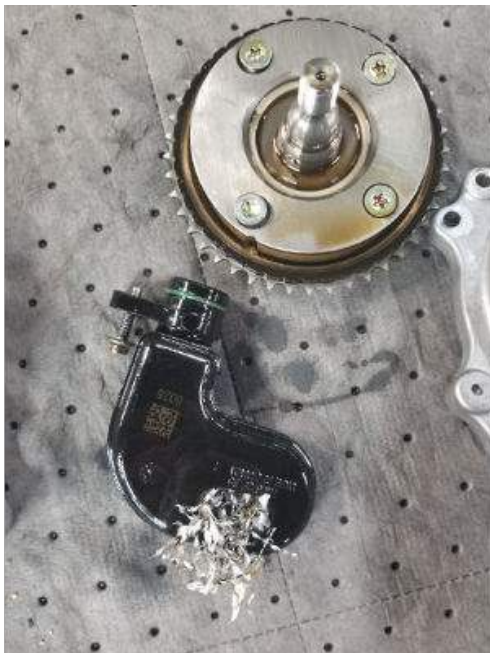
6331432

Picture below showing torx screws on the Intake Cam Actuator that have come loose and the amount of aluminum debris in the pick up tube that's possible when the screws contact the Cam Carrier face.

If the Cam Carrier face is not damaged and there is no abnormal metal in the engine oil then replace the Intake Cam Actuator, any necessary components and change engine oil and filter.
