### Check engine light active - Fault P3007F1, P3007F2, P300CA8, or P300CA9 present in CDI control unit

| Topic number | LI14.30-N-075882 |
| Function group | 14.30 - Secondary air injection |
| Validity | Model 907 with engine 654 |

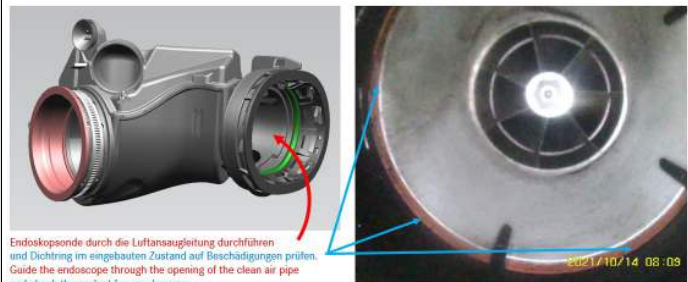
- If there is a leakage upstream of the exhaust gas turbocharger (see "Dichtring\_Sealant.jpg").
- If the housing intermediate flange at the high-pressure EGR valve (where the exhaust back pressure sensor connects) is carbonized or clogged, or if there is carbonization/incomplete sealing of the high-pressure or low-pressure EGR valves. (See "Gehaeusezwischenflansch\_intermediate\_flange.jpg" and "verstopfter\_Gehaeusezwischenflansch\_clogged\_Intermediate\_Flange.jpg".)

| File | Description |
|---|---|
| <a href="#">Dichtring_Sealant.jpg</a> <div><p>Endoskopsonde durch die Luftansaugleitung durchführen und Dichtung im eingebauten Zustand auf Beschädigungen prüfen.<br/>Guide the endoscope through the opening of the clean air pipe and check the sealant for any damages</p></div> | |

- Inspect the sealing ring between the exhaust gas turbocharger and the clean air line for damage with an endoscope (see annex "Dichtring\_Sealant\_nok").
- Repair/replace as needed.

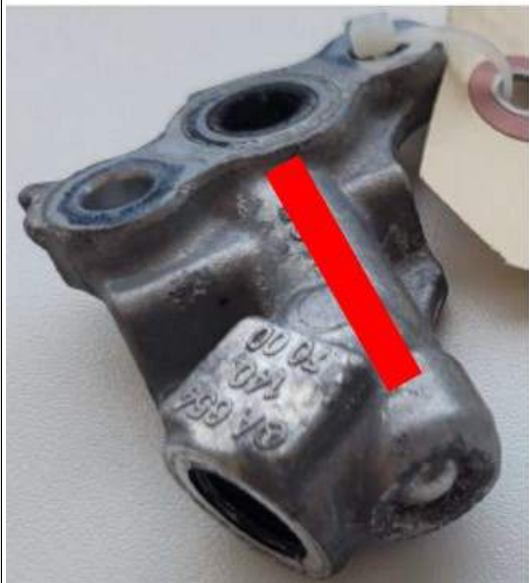
| File | Description |
|---|---|
| <a href="#">Gehaeusezwischenflansch_Intermedidate_Flange.jpg</a> <div></div> | |

- There is carbonization or incomplete closure of the high-pressure exhaust gas recirculation valve, especially in the housing intermediate flange at the EGR valve (linked to the exhaust back pressure sensor).

1) Inspect the housing intermediate flange on the high-pressure exhaust gas recirculation (EGR) valve, specifically at the connection for the exhaust back pressure sensor. Use a flashlight to check for any inconsistencies or carbon buildup.

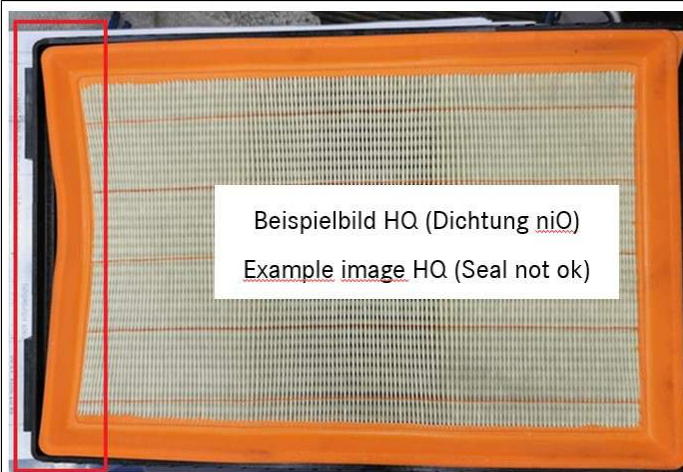
Beispielbild HQ (Dichtung niO)  
Example image HQ (Seal not ok)

- Inspect the clean air line between the air filter housing and the exhaust gas turbocharger for proper assembly.
- Reference WIS documents: AR09.10-S-8130EA, AR09.40-S-0500EA (dual-stage turbo), AR09.20-S-0010EA, and/or AR09.41-S-6817EA.
- Confirm correct assembly and all connections:
- Ensure proper seating and locking of all quick-release couplings (see provided images and WIS refs).
- For dual-stage turbochargers, confirm the cast lug aligns with the tab. (See picture 1c.)
- Note: Always replace the red sealing ring (see annex "Dichtring\_Sealant\_nok") during assembly/repairs.

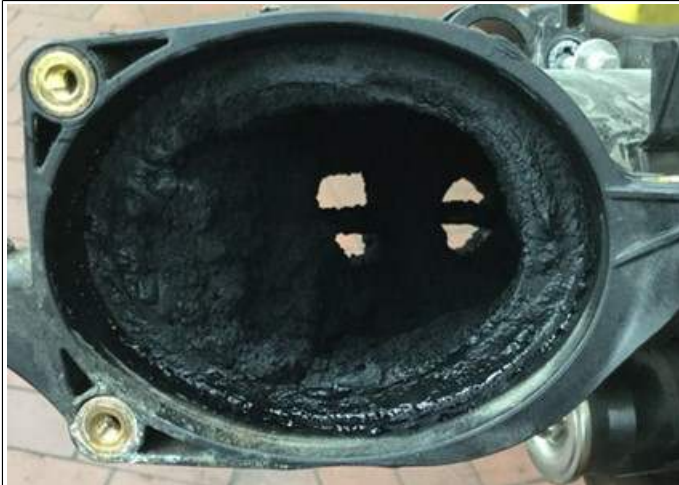
[Saugrohr\\_Intake\\_manifold\\_II.jpg](#)

- Note: Only relevant if the correction value in load range 1 is less than -8%.
- If the intake manifold (charge air distribution line) or charge air cooler is carbonized (see "Saugrohr\_intake\_manifold.jpg").

- There is a leak downstream of the exhaust gas turbocharger.
- The charge air distribution line (intake manifold) is heavily carbonized (see "Saugrohr\_intake\_manifold.jpg").
- There is carbonization or incomplete closure of the high-pressure exhaust gas recirculation valve, especially in the housing intermediate flange at the EGR valve (linked to the exhaust back pressure sensor).
- There is a defective hot film mass air flow sensor, or it is affected by incorrect airflow due to a clogged or deformed air filter (see "Luftfilter\_air\_filter").

- Inspect the following for severe carbon build-up or other inconsistencies:
- Intake manifold (charge air distribution line) – see "Saugrohr\_intake\_manifold.jpg."
- Housing intermediate flange at the high-pressure EGR valve (exhaust back pressure sensor connection, use a flashlight).
- Only necessary if the air intake correction value in load range 1 is less than -8%.
- Charge air cooler.
- Initiate repairs/cleaning as needed.
- If issues are found in the intake manifold, also check the cylinder head intake ports.
