**UPDATED JANUARY 23, 2026 – Added video tutorial for procedure.  
Modified to further highlight modules to be updated.**

## 2024-2026 CX-90 and 2025-2026 CX-70 Engine Warning Light Illumination with DTC PODAB

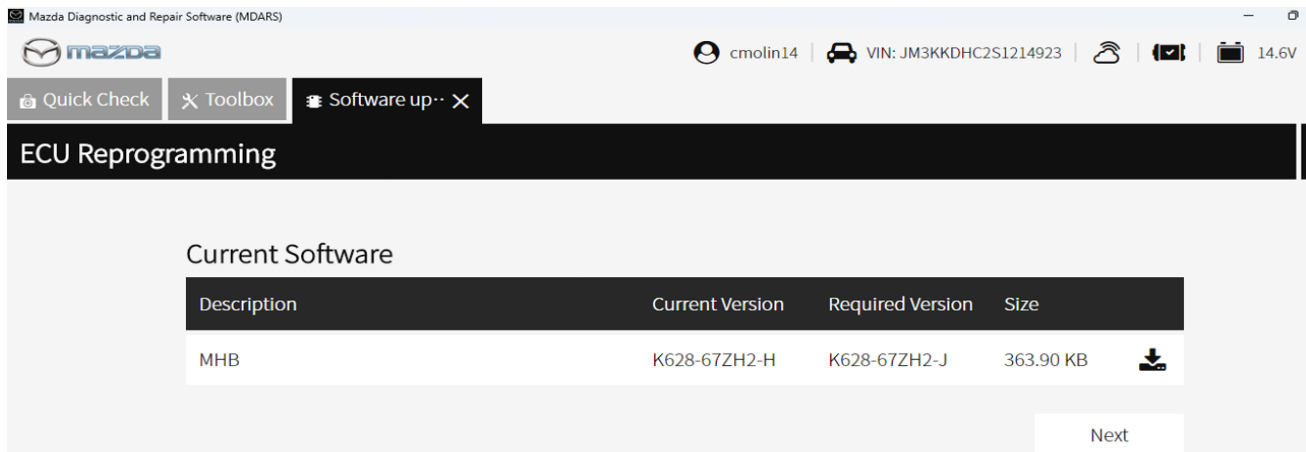
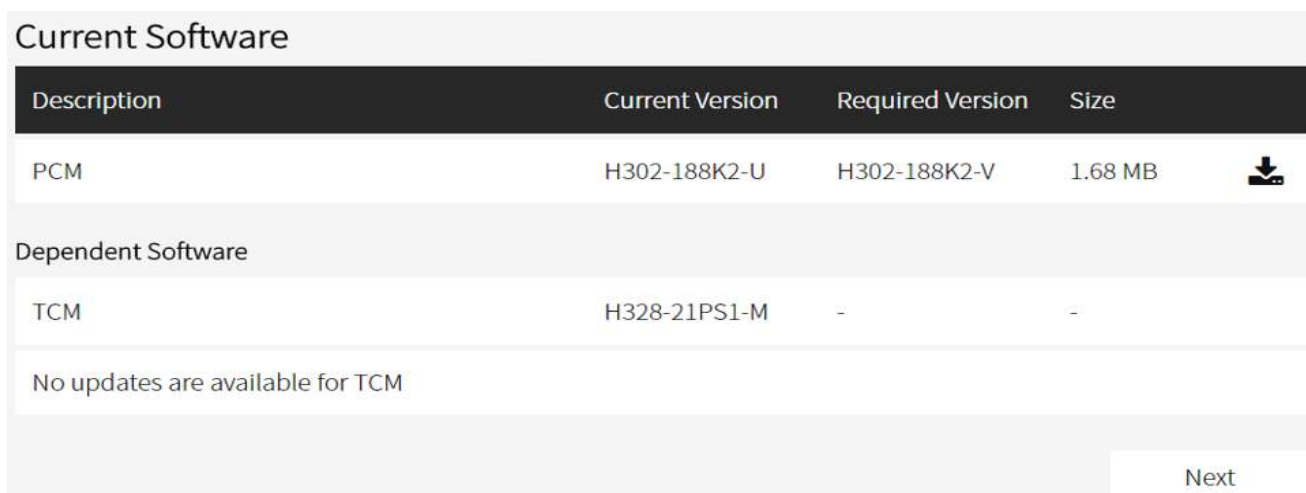
3. Confirm the current and new software versions, click "Next". CX-90 Example shown. If the software is at the current level, do not stop repairing and continue with all remaining steps including Uploading ODR data and Campaign Label Installation.

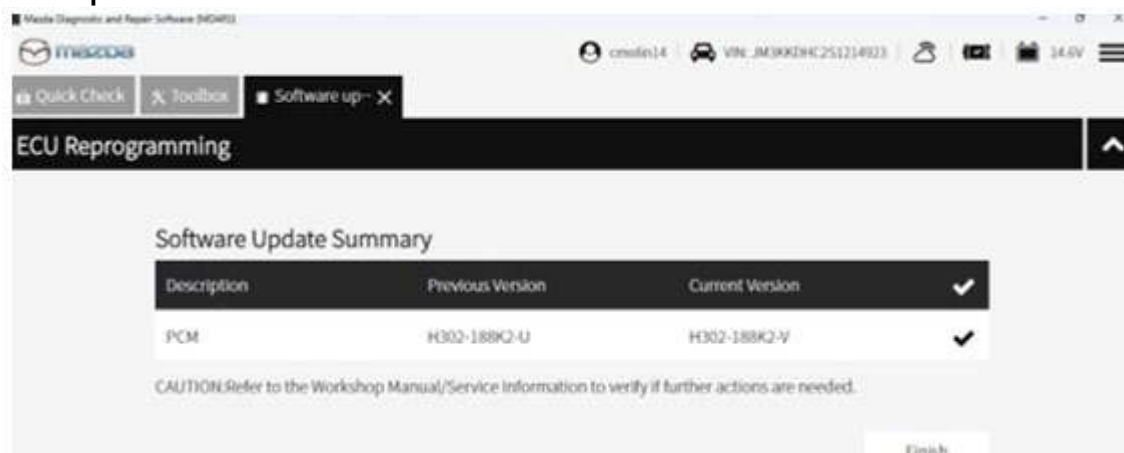
### CX-90 Example

4. Wait for the download and click "Next".
5. After completion of software update, the previous and current software version are shown.
  - Check current version at "Calibration File information below".
  - Then, click on "Finish" to exit the ECU reprogramming.

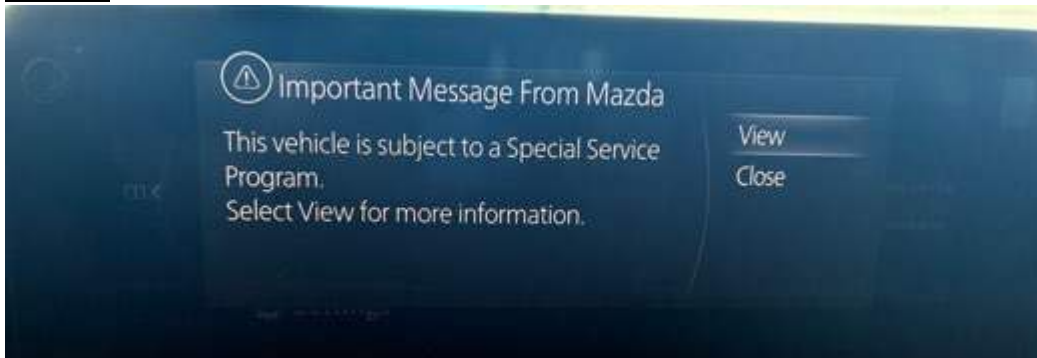
**Photo 1**

**Step 1: Verify the message is in the View Status Monitor in Mazda Connect Inbox. Once at the main screen, select “View” then you will see photo 2.**
