# Technical Service Bulletin

| <b>Topic</b> | Window Drop Glass Operation Continental GT/GTC 25-26MY |
| <b>Transaction No.</b> | 2080372/1 |

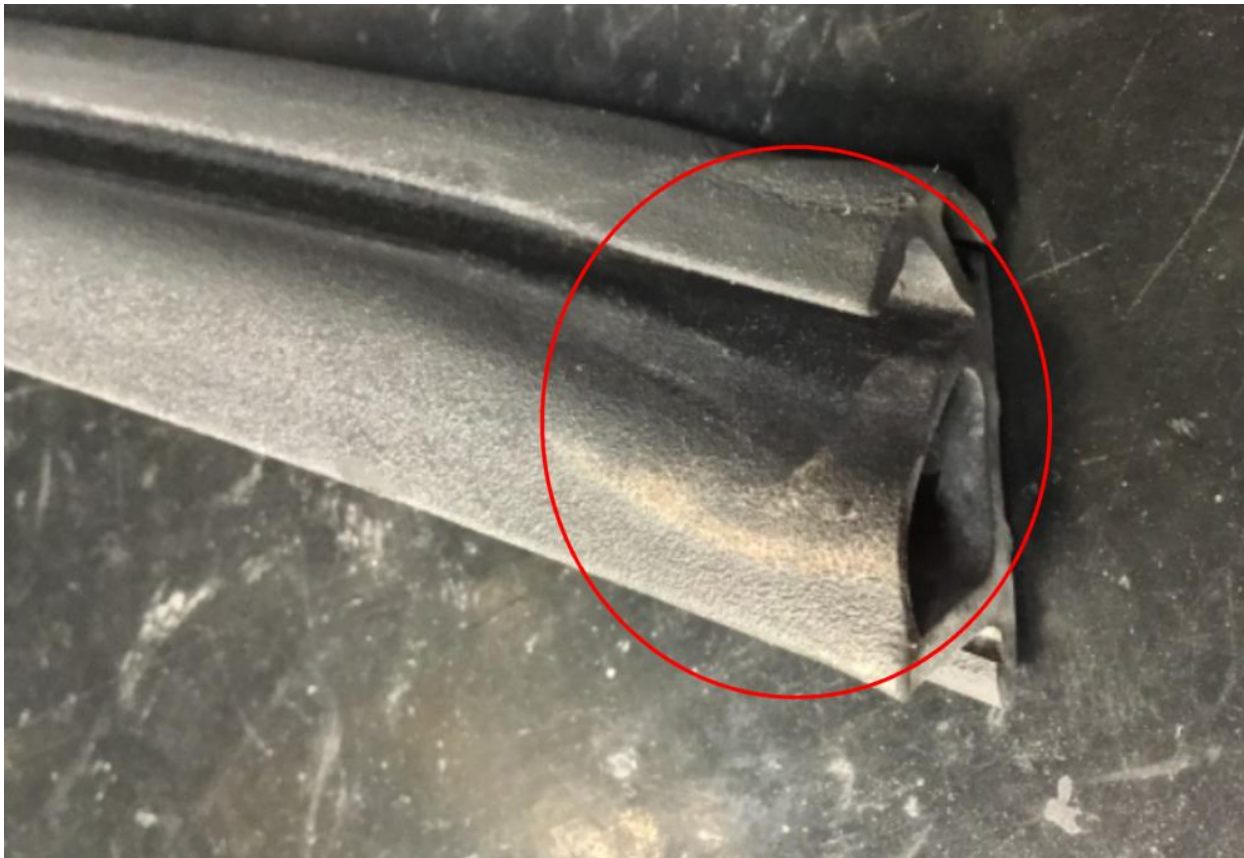
Figure 1

- Damage
- Splits
- Tears
- Misalignment
- Incorrectly fitted / located
- Drop glass seal deformation (see Figures 1 and 2 as examples)

**NOTE:** Any issues found with the window seals must be rectified before conducting the remaining steps

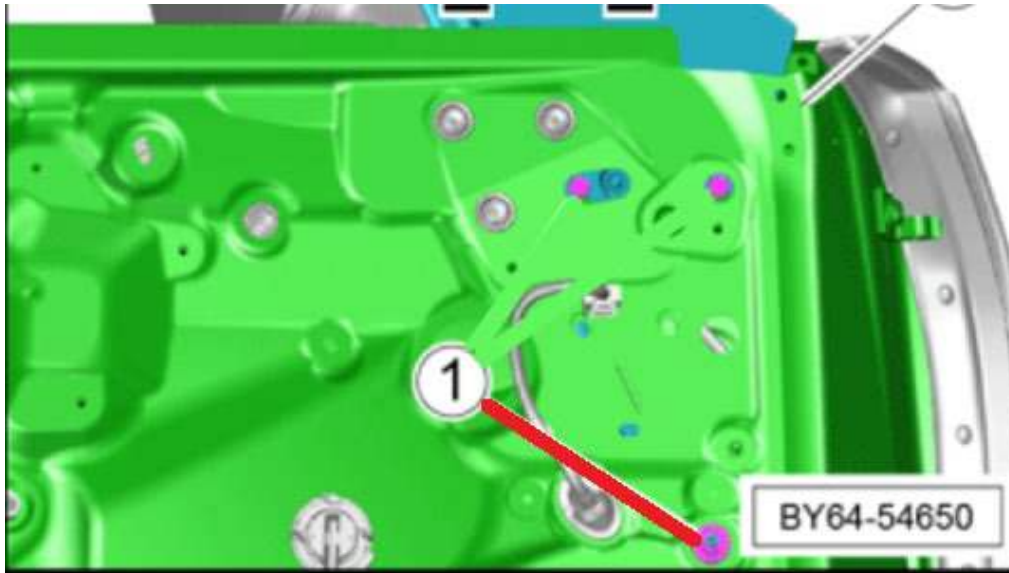
*Figure 1. Image for reference, glass does not require removal from vehicle*

The measurement between the bottom of the mounting washer and division bar frame, is 12.5mm.

1. loosen the lock nut.
2. Screw the adjuster fully clockwise until it bottoms out on the frame.
3. Unscrew the adjuster counterclockwise by four complete turns.
4. Resecure the lock nut.

Finally, set the height and profile to the TPI specification before proceeding to the next step.

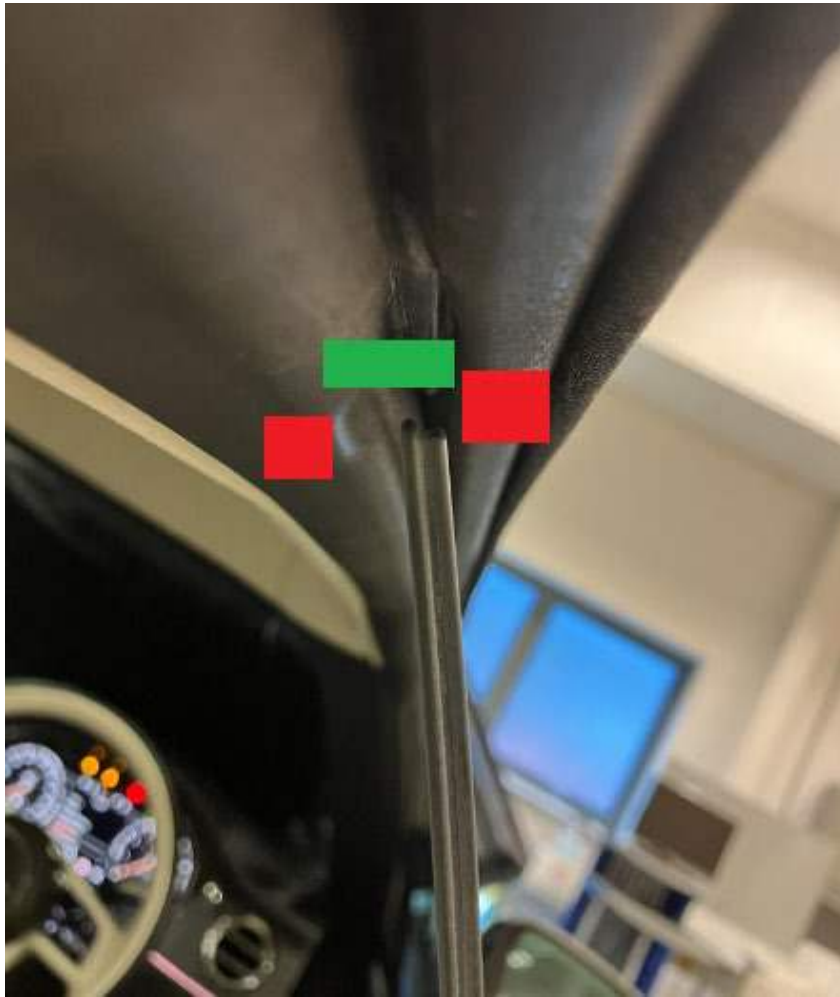
Front Window example showing correct operation

Windows should enter cant rail seal smoothly, making contact with green area.

For the front door, poor door profile point is a major contributing factor here and should be checked/adjusted if window found to be entering seal incorrectly.

If this is not correct, it will cause the window to bounce back causing a loss of basic settings.

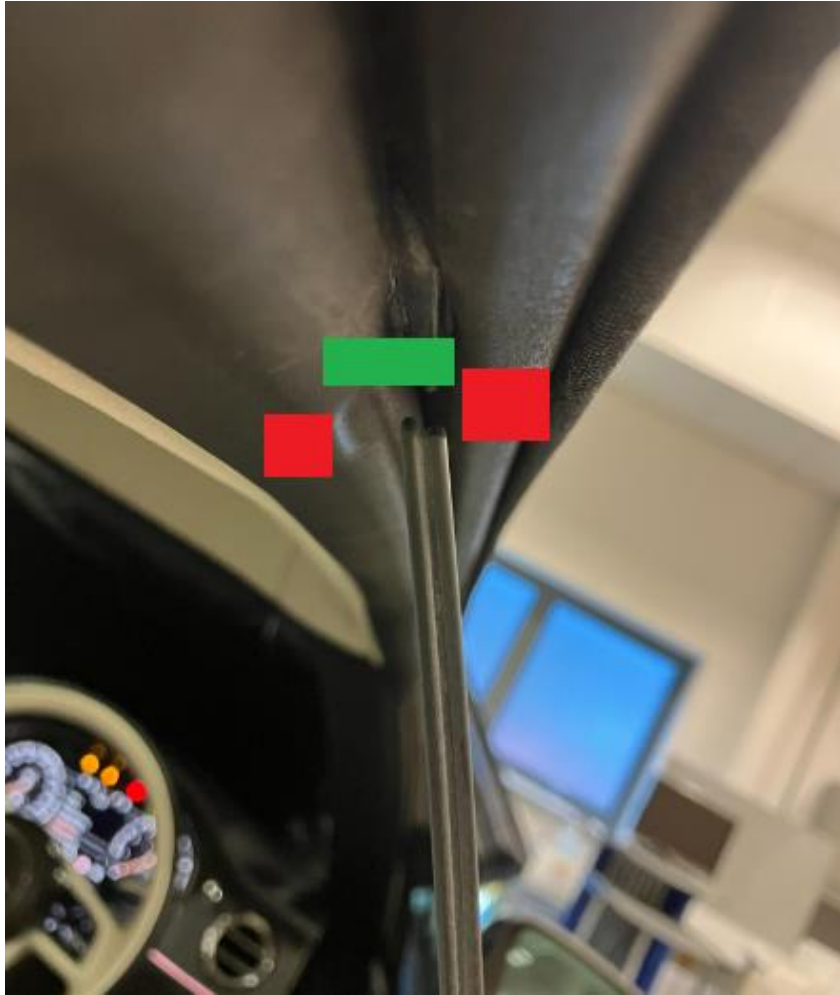
Front Window example showing correct operation

Windows should enter cant rail seal smoothly, making contact with green area.

For the front door, poor door profile point is a major contributing factor here and should be checked/adjusted if window found to be entering seal incorrectly.

If this is not correct, it will cause the window to bounce back causing a loss of basic settings.
