## Technical Service Bulletin (TSB)

### Clutch Switch Failure

| REFERENCE: | TSB: 08-022-26<br>GROUP: 08 - Electrical | Date: | January 28, 2026 | REVISION: | 08-393-25 |
| VEHICLES AFFECTED: | 2025 (JL) Jeep Wrangler<br>This bulletin applies to vehicles equipped with 6-Speed Manual Transmission (Sales Code DEM). | | | MARKET APPLICABILITY:<br><div><input checked="" type="checkbox"/> NA<input type="checkbox"/> MEA</div> <div><input type="checkbox"/> SA<input type="checkbox"/> IAP</div> <div><input type="checkbox"/> EE<input type="checkbox"/> CH</div><br><b>NOTE:</b> This bulletin applies to North America market. | |

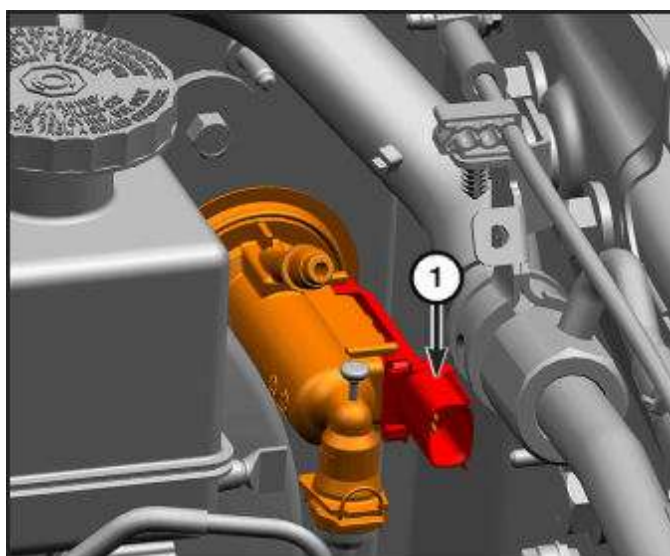
**Fig. 1**  
Clutch Starter Interlock Switch

| CAUSE: | Clutch interlock switch electrical terminal corrosion | | | | |

1. \*\*Replace the Clutch Interlock Switch [Fig. 1](#). Refer to the detailed service procedures available in DealerCONNECT/Service Library under: Service Info> 06 - Clutch / Switch, Clutch Starter Interlock / Removal and Installation.

2. Clean the clutch interlock switch electrical connector terminals using electrical contact cleaner and compressed air to remove any corrosion present.
