# Technical Service Bulletin

| <b>Topic</b> | Window Drop Glass Operation Continental GT/GTC 19-24MY |
| <b>Transaction No.</b> | 2080375/1 |
| <b>Release date</b> | Jan 20, 2026 |

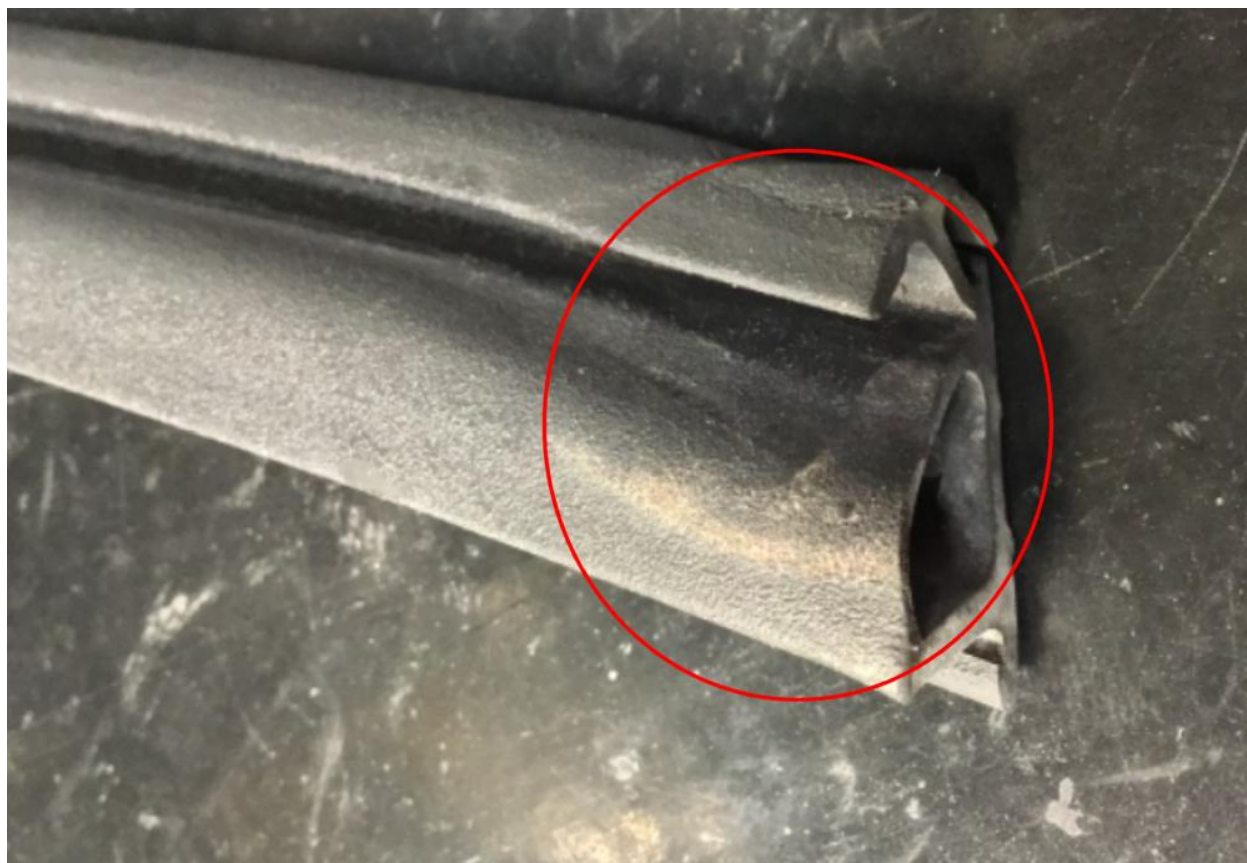
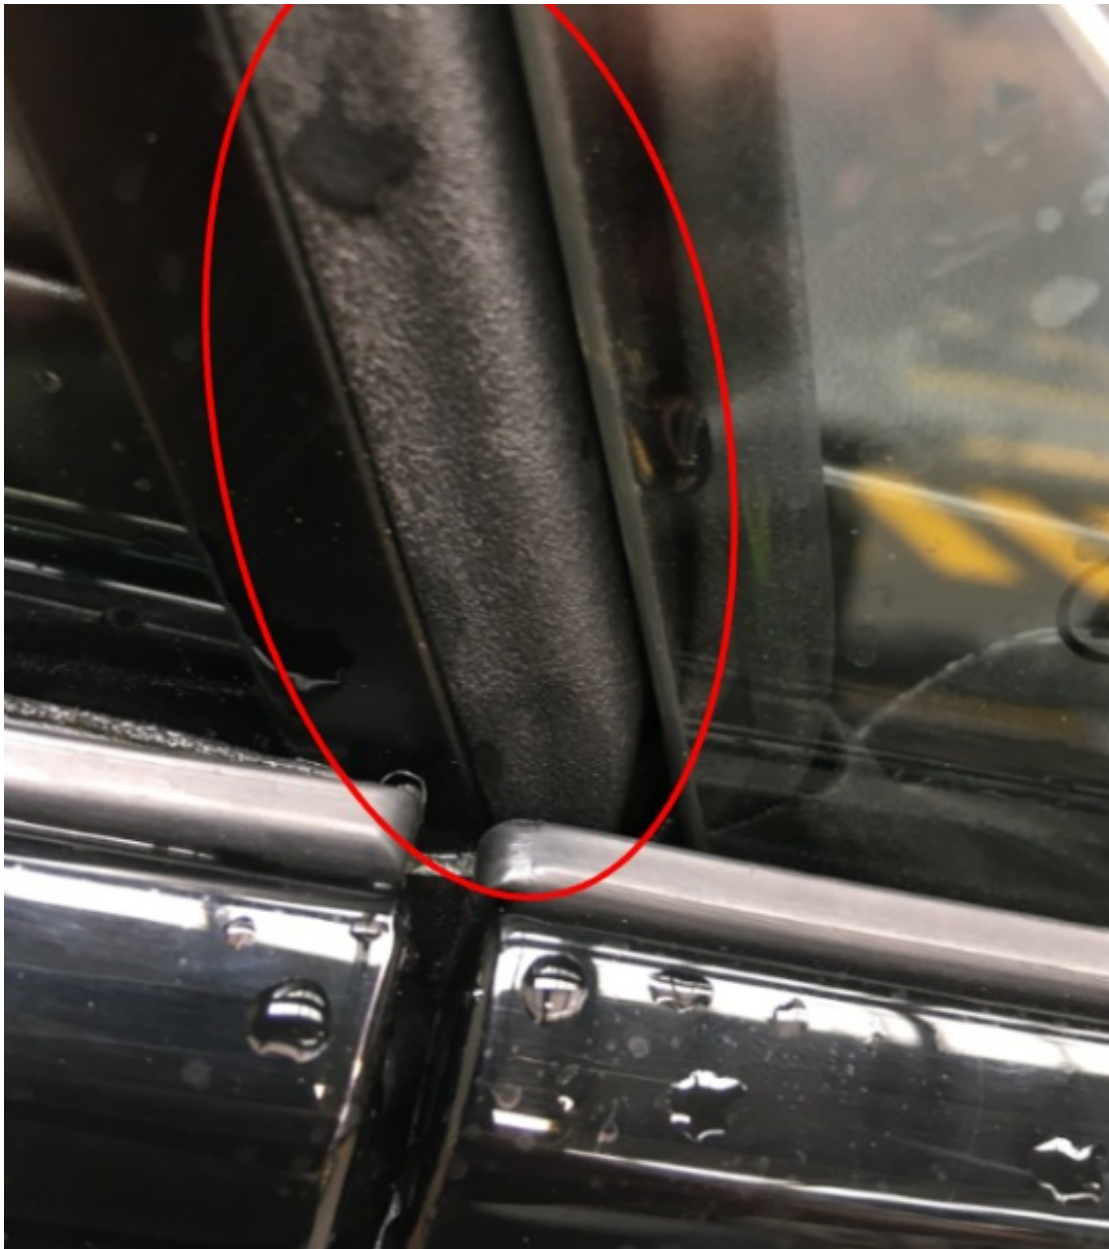
Figure 7

- Damage
- Splits
- Tears
- Misalignment
- Incorrectly fitted / located
- Drop glass seal deformation (see Figures 7 and 8 as examples)

**NOTE:** Any issues found with the window seals must be rectified before conducting the remaining steps

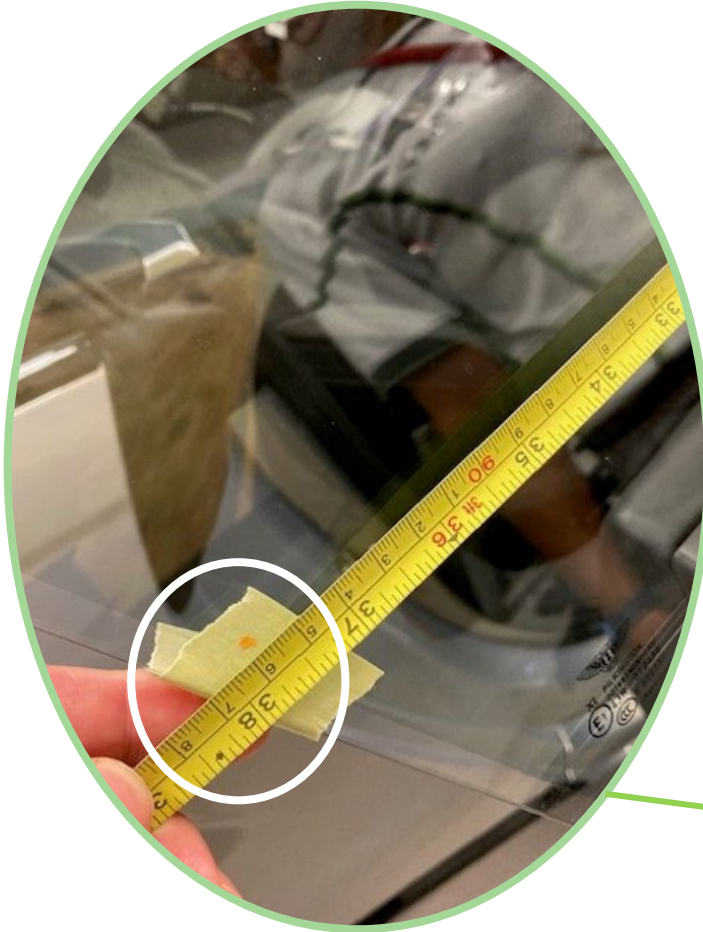
Measuring from front div bar to rear of  
the glass

**Specification**  
971mm  $\pm$  1mm

If out of specification, refer to the next  
slide to adjust the glass position

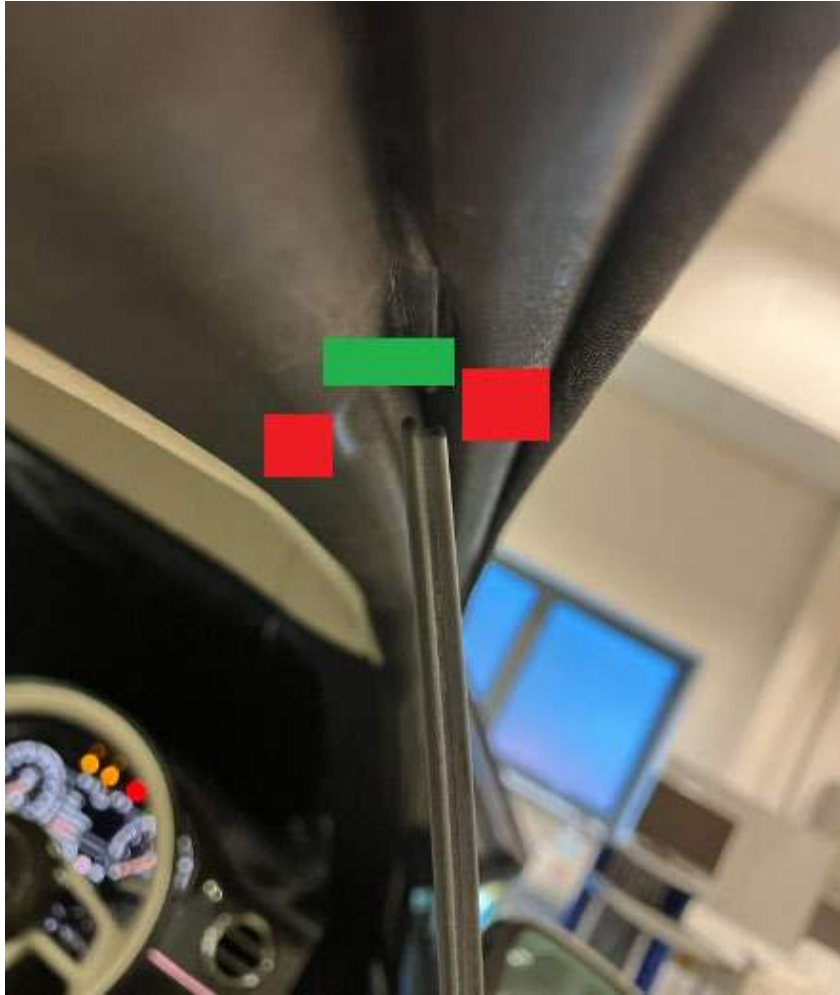
Front Window example showing correct operation

Windows should enter cant rail seal smoothly, making contact with green area.

For the front door, poor door profile point is a major contributing factor here and should be checked/adjusted if window found to be entering seal incorrectly.

If this is not correct, it will cause the window to bounce back causing a loss of basic settings.
