# Technical Service Bulletin

| Topic | Turbo Charger Under-boost - DTC P029900 is evident in 0001 V8 Kovomo All Models |
| Brand | Bentley |
| Transaction No. | 2079115/1 |

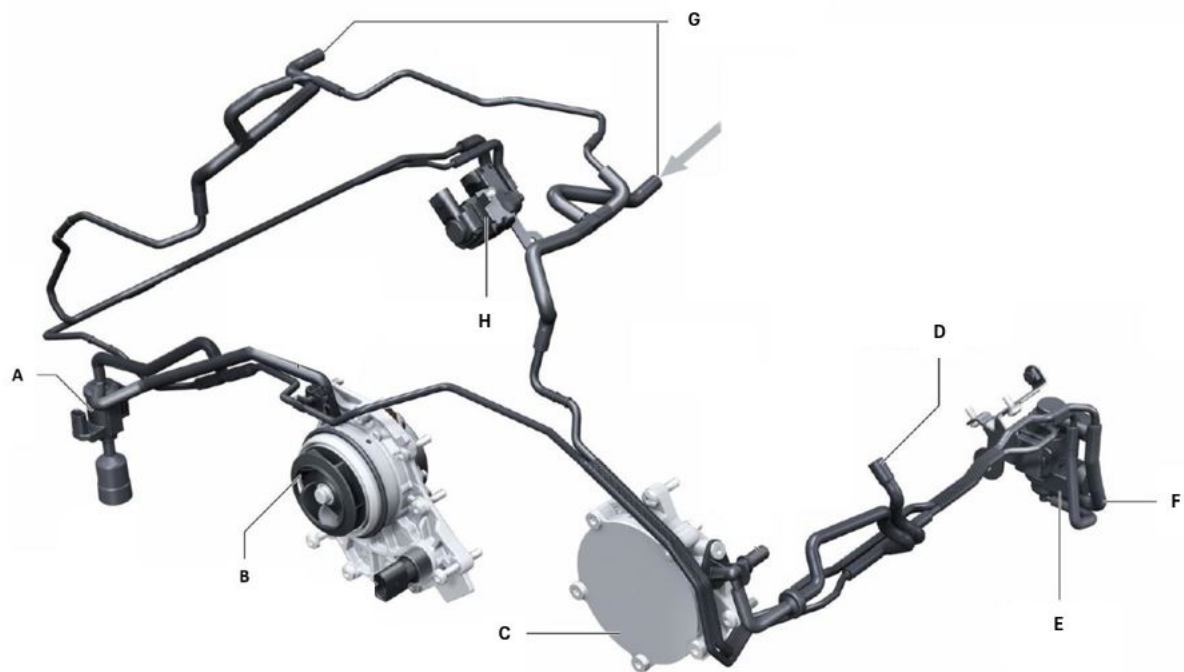
**Vacuum System Layout – Use for Illustration purposes only**

The wastegate actuator relies on vacuum pressure to regulate turbocharger boost. If vacuum is not maintained, the wastegate may remain open, preventing the turbocharger from generating full boost. This can trigger engine protection mode, limiting performance and displaying warnings in the DIP. Refer to the measure section for guided fault-finding steps.
