## Technical Service Bulletin

Transaction No.: **2076994/6**

27 Valeo 48V starter generator (BSG) DTC P0A1A00 P19F800 P0A1E00 U014600  
U300100 P10F300 P056200 P056100 P065200 P069800

Release date: Jan 5, 2026

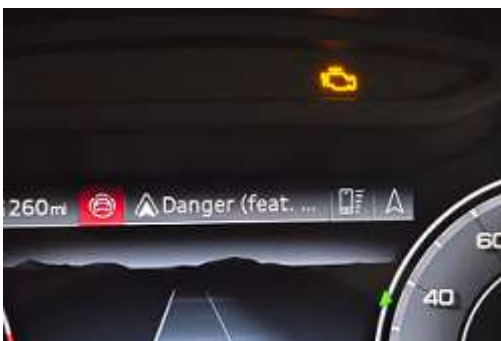
- The engine warning lamp (MIL) is on (Figure 1).

**Figure 1.** MIL is illuminated.
