## Condition

| Model(s) | Year(s) | VIN Range | Vehicle Specific Equipment |
|---|---|---|---|
| A6 Sportback e-tron,<br>S6 Sportback e-tron,<br>Q6 e-tron, Q6<br>Sportback e-tron,<br>SQ6 e-tron, and SQ6<br>Sportback e-tron | 2025 | All | Not applicable |

At the start of a trip, the warning “High-voltage electrical system: fault. Please contact workshop” (Figure 1) appears in the instrument cluster. The drive system is not activated. The remaining range is displayed as 0 miles (0 km).

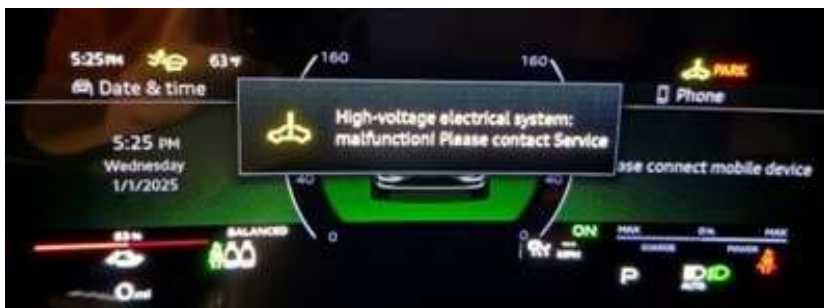
**Figure 1.** The above message appears at the start of the trip in the instrument cluster.

Software issue.

To permanently rectify the fault, please perform the software update described in TSB 2079690 00 Combined software update 03.10.00/C (28.13.01) KD2.
