## Technical Service Bulletin

Transaction No.: **2078134/3**

93 Q4 e-tron - electric drive system warning lamp lights up / event memory entry:  
P0BBD00 in 008C

Release date: Jan 5, 2026

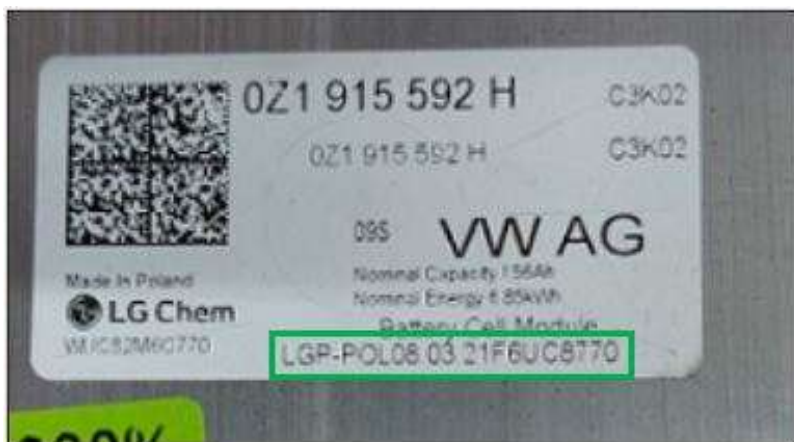
- Remove and open the high-voltage battery as per the Workshop Manual.
- Check the manufacturing date on type plate of the battery module to be renewed (see Figure 1):

- The consecutive production number (see Figure 1, highlighted in green) also includes the manufacturing date of the battery module. The manufacturing date of the battery module from the example (see image 1, highlighted green): LGP-POL **08.03.21** F6CUC8770 would therefore be **03/08/2021**.

**Figure 1.** Example image of a battery module type plate with production date: 08 03 21 (= 08.03.2021).

- If the battery module that must be replaced has a manufacturing date **prior to 12/04/2023 and** has one of the following part numbers: 0Z1.915.592.G, 0Z1.915.592.H, 0Z1.915.592.J, 0Z1.915.599.G, 0Z1.915.599.H, 0Z1.915.599.J, 0Z1.915.599.P, the battery module must be replaced according to the Workshop Manual/parts catalogue.

- If a battery module with a manufacturing date **from 12/04/2023 onwards** is installed, a *technical repair query* must be created.
