## Condition

**THIS IS A TECH TIP, NOT A TECHNICAL BULLETIN.**  
**TECH TIPS ARE NOT ASSOCIATED WITH WARRANTY CLAIMING.**

### Applicable Vehicles

## Technical Background

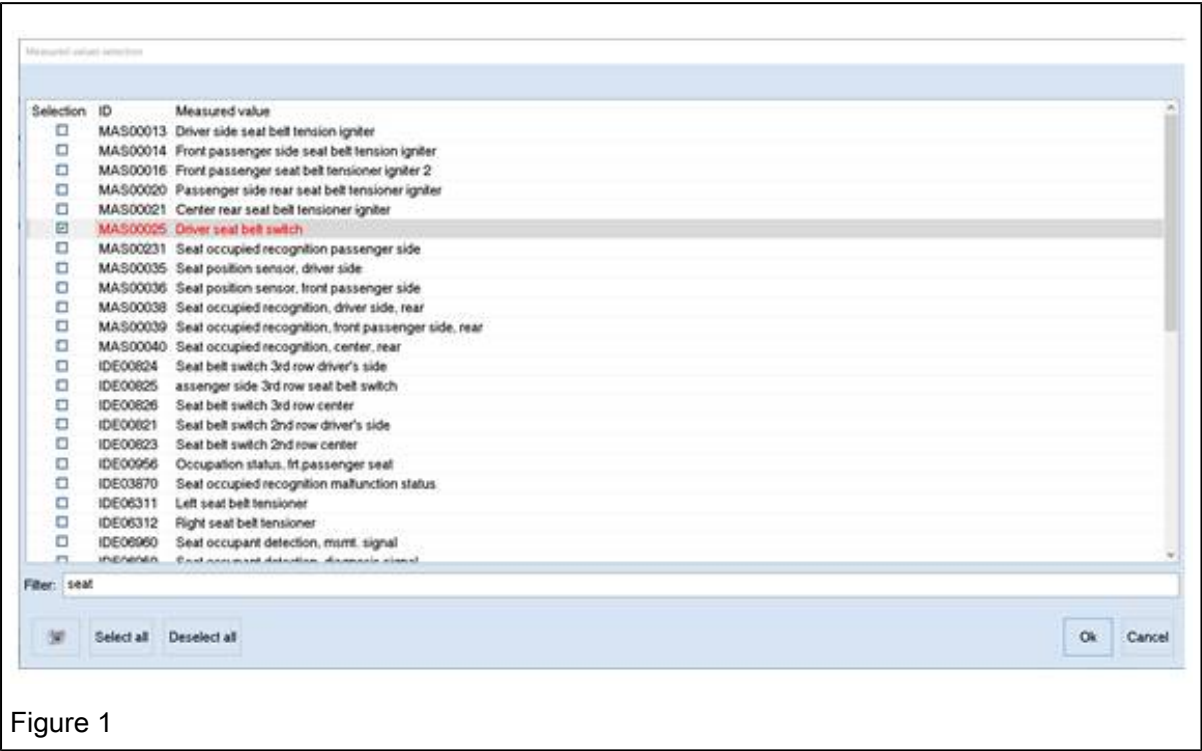
Figure 1

For Airbag Control Unit (diagnostic address 0015), read MVB “MAS00025 - Driver Seat Belt Switch” (figure 1). You should see the status change between “connected” (figure 2) and “not connected” (figure 3) when fastening & unfastening the seat belt.

Do not perform any repair unless the safety belt switch status will NOT change state.
