## 992 2WD – DME Fault P310B00 – ‘Fuel Low Pressure – Implausible’

### Condition

Customer complains of a check-engine light resulting from fault “**P310B00- Fuel low pressure – implausible**” in the DME control unit.

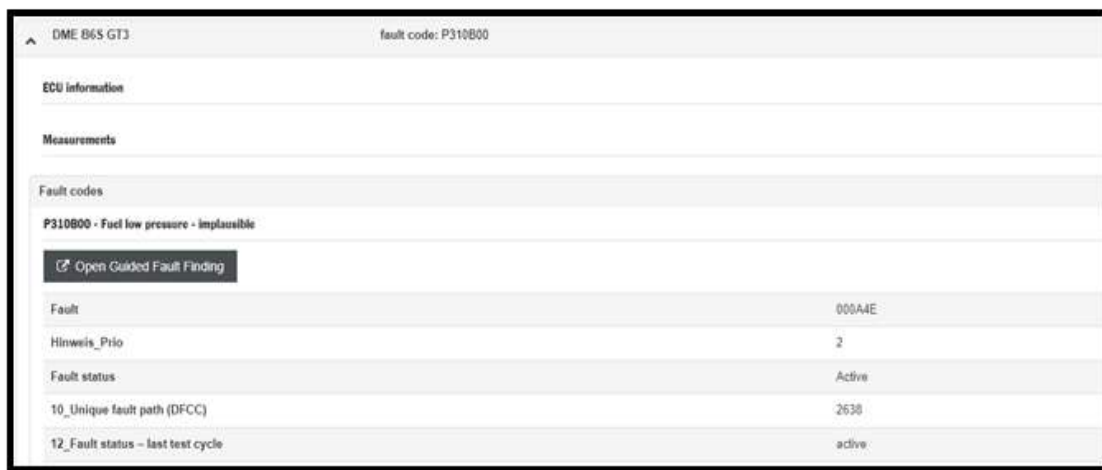
Figure 1

The diagnostic responsible for this fault monitors supply deviation within a finite time between the demanded or target low-pressure requested of the low-pressure fuel pump and that of the actual supplied quantity to meet the request, as correlated to pressure. In some instances, manufacturing tolerances for the low-pressure pump result in the actual supplied fuel quantity exceeding the DME's requested quantity, in other words, the pump's operation is 'too effective.' By consulting the Vehicle Analysis Log (VAL) containing the fault it is possible to see if the supplied fuel quantity exceeded the requested quantity in the low-pressure system to cause the fault.

In the example provided below of Figure 2, with imperial units provided, it is apparent the excess low-pressure fuel supply caused the fault. Specifically, the value "B220\_Fuel pressure actual value" of 10653.7 lbf/ft<sup>2</sup> exceeds "B221\_Fuel low pressure setpoint" of 10442.7 lbf/ft<sup>2</sup>. This deviation occurred despite the DME regulating the demand downwards (-) by 1948.6 lbf/ft<sup>2</sup> or 14.99% to compensate for the excess supply, but the regulation could not compensate enough to prevent the fault.

If the fault data is consistent with the condition exemplified in Figure 1, please replace the fuel pump, **NOT** the fuel pressure sensor.
