## Technical Service Bulletin

| ENGINE<br>MECHANICAL | 26-EM-003H |
| FEBRUARY 2026 | SONATA<br>(DN8/DN8A) |

**SUBJECT:** INTEGRATED THERMAL MANAGEMENT (ITM) REPLACEMENT & ECM/TCU SOFTWARE UPDATE – DTCS P218100, P2181F0, P2181F1

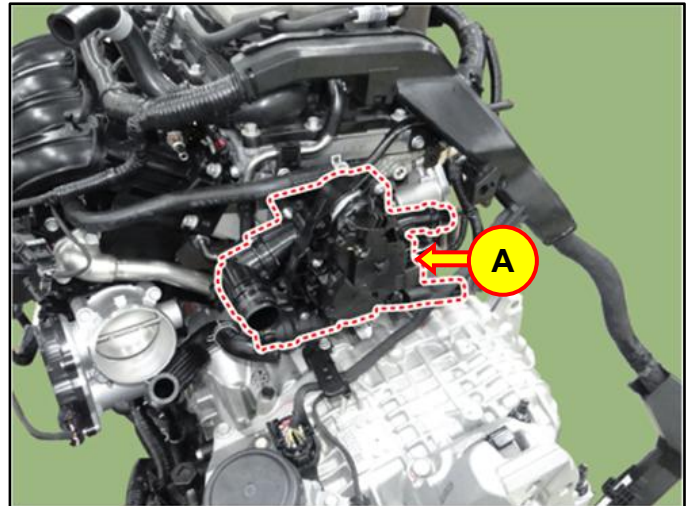
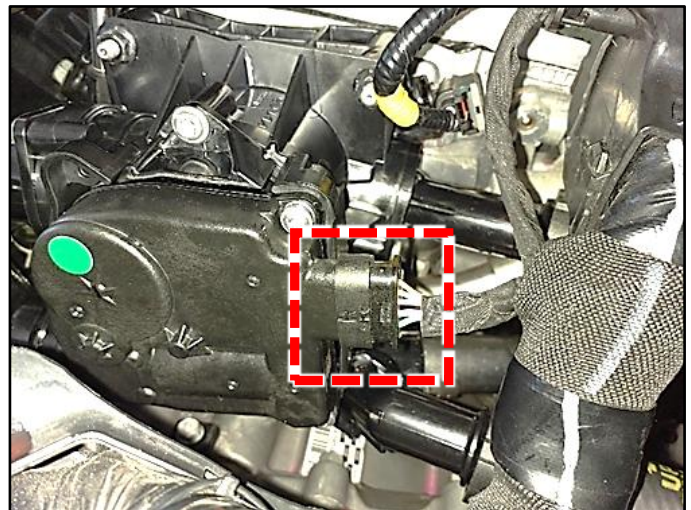
The ITM design inverts the connector's orientation.

2. Replace the ITM (A) by referring to the shop manual.
  - **Engine Mechanical System > Cooling System > Integrated Thermal Management Module (ITM) > Repair procedures**
3. Reinstall parts in the reverse order of the removal process.
