# HYUNDAI

## Technical Service Bulletin

| GROUP<br><b>ENGINE<br/>MECHANICAL</b> | NUMBER<br><b>26-EM-004H</b> |

**SUBJECT:** INTEGRATED THERMAL MANAGEMENT (ITM) REPLACEMENT & ECM/TCU SOFTWARE UPDATE – DTC P218100, P2181F0, P2181F1

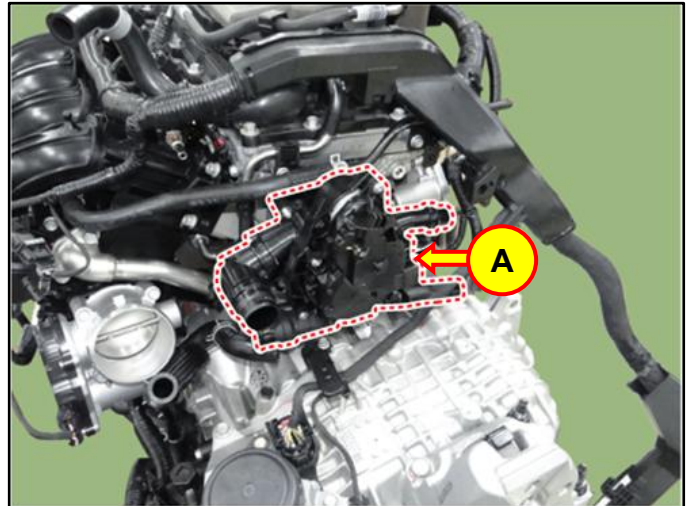
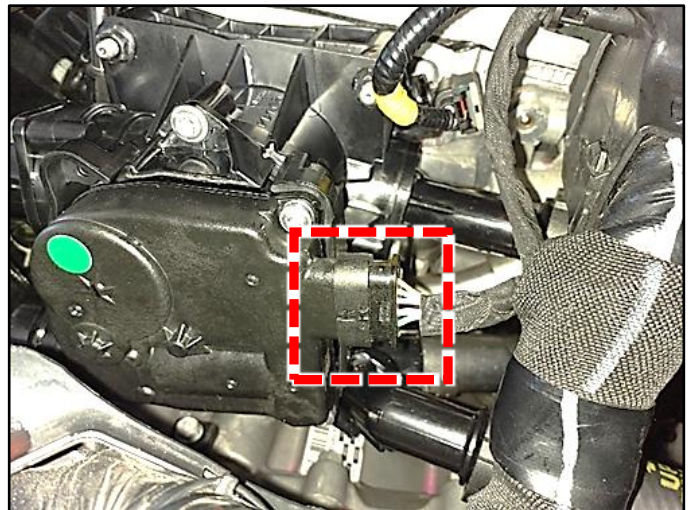
The ITM design inverts the connector's orientation.

1. Replace the ITM (A) by referring to the shop manual.
  - **Engine Mechanical System > Cooling System > Integrated Thermal Management Module (ITM) > Repair procedures**
2. Reinstall all parts in the reverse order of the removal process.
