| <b>HYUNDAI</b><br><b>Technical Service Bulletin</b> | GROUP<br><b>ENGINE<br/>MECHANICAL</b> | NUMBER<br><b>26-EM-005H</b> |
| | DATE<br><b>FEBRUARY 2026</b> | MODEL(S)<br><b>SANTA FE (TMA)</b> |
| <b>SUBJECT:</b> INTEGRATED THERMAL MANAGEMENT (ITM) REPLACEMENT & ECM/TCU SOFTWARE UPDATE – DTCS P218100, P2181F0, P2181F1 | | |

**Description:** Some Santa Fe (TMA) vehicles may have DTCs P218100, P2181F0, and/or P2181F1 (Cooling System Performance) set in the Electronic Control Unit (ECU), resulting in an illuminated Check Engine warning lamp. Follow the procedure in this TSB to replace the Integrated Thermal Management (ITM) module and update both the the Engine Control Module (ECM) and Transmission Control Module (TCM) if applicable. Follow the flowchart in this TSB to update the appropriate modules.

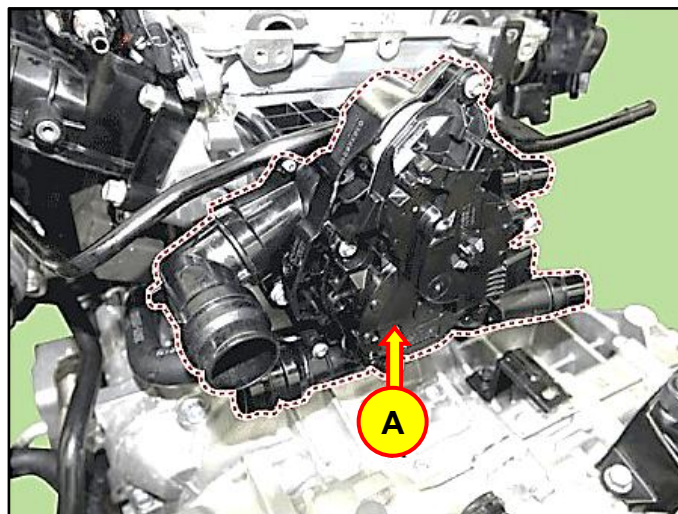
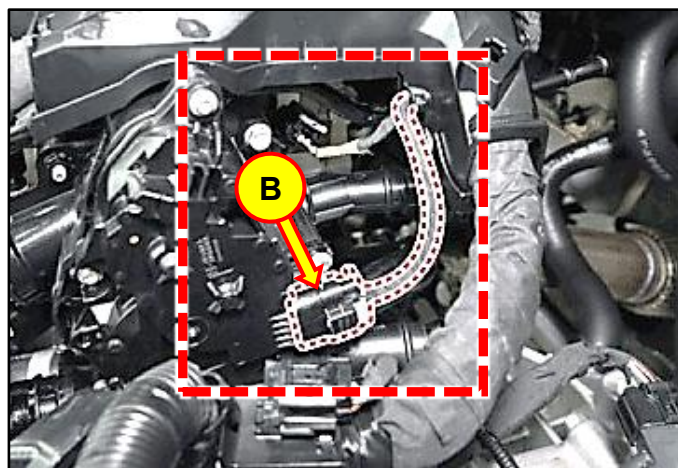
The ITM design inverts the connector's (B) orientation.

2. Replace the ITM (A) by referring to the shop manual.
  - **Engine Mechanical System > Cooling System > Integrated Thermal Management Module (ITM) > Repair procedures**
3. Reinstall parts in the reverse order of the removal process.
