## TECHNICAL SERVICE BULLETIN

### "Steering Assist Fault Service Required" Message In The IPC And Reduced Steering Assist With DTCs U3008:1B And/Or U3009:1B Stored In The PSCM

**26-2035**  
04 February 2026

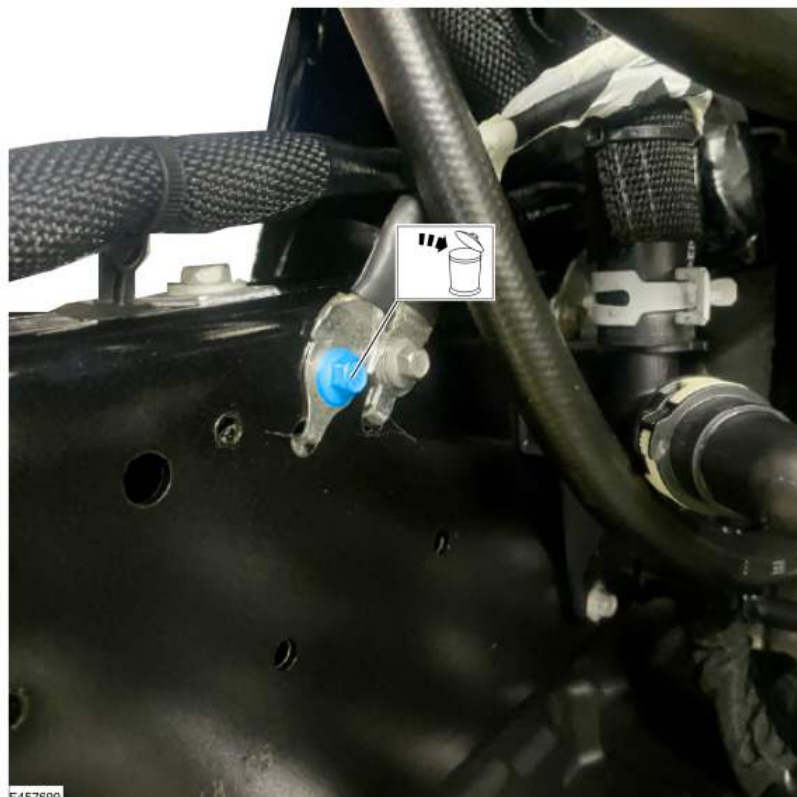
Figure 1

2. No - proceed to Step 4.
3. Does the vehicle exhibit DTCU3009:1B?
  1. Yes - proceed to Step 12.
  2. No - this article does not apply. The ground connection for U3008:1B has been relocated on 2026 Aviator only. Refer to the WSM, Section 211-02 for normal diagnostics.
4. For hybrid vehicles only, remove the cooling module. Refer to WSM Section 303-03 > Removal and Installation > Cooling Module.
5. For gas vehicles only, remove the engine front undershield. Refer to WSM, Section 501-02 > Removal and Installation > Engine Front Undershield.
6. Remove and discard the M6 fastener from ground G104 (Explorer/Police Interceptor Utility) or G116 (Aviator) on the passenger side frame rail. Refer to Wiring Diagram Cell 151 for connection locations. (Figure 1)

7. Carefully enlarge the existing holes in the frame rail sheet metal and the harness eyelet by drilling with a 7 mm (9/32 in.) drill bit.
8. Reinstall ground G104 (Explorer/Police Interceptor Utility) or G116 (Aviator) using the new self-tapping M8 fastener. Make sure the ground eyelet locating tab is properly aligned with the alignment hole in the frame. Tighten to 71 lb.in (8.0 Nm).
