## Technical Service Bulletin (TSB)

### Flash: Powertrain Control Module (PCM) Updates

| REFERENCE: | TSB: 18-018-26<br>GROUP: 18 - Vehicle Performance | Date: | February 11, 2026 | REVISION: | 18-078-24,<br>18-053-24,<br>18-076-24 |
| VEHICLES AFFECTED: | <b>**2023 - 2026** (M6) Jeep Compass (India)</b><br>This bulletin applies to vehicles built on and after <b>**March 01, 2023 (MDH 0301XX)</b> and on and before January 12, 2026 (MDH 0112XX)** equipped with a 2.0L I4 Turbo Diesel Engine W/ESS (Sales Code EBS). | | | <b>MARKET APPLICABILITY:</b><br><div><input type="checkbox"/> NA<input type="checkbox"/> MEA</div> <div><input type="checkbox"/> SA<input checked="" type="checkbox"/> IAP</div> <div><input type="checkbox"/> EE<input type="checkbox"/> CH</div><br><b>NOTE: **This bulletin applies to the India &amp; Asia Pacific market.**</b> | |

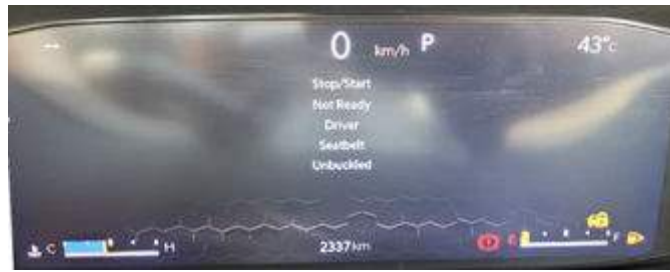
**Fig. 1**  
IPC Message

| CUSTOMER SYMPTOM: | <b>**Customers must experience a Malfunction Indicator Lamp (MIL) illumination and the vehicle must exhibit/set the following Diagnostic Trouble Code (DTC):</b> <ul style="list-style-type: none"><li>P2002 - Diesel Particulate Filter Flow Resistance Monitoring Too High Level 2 Component Or System Operation Obstructed Or Blocked.</li></ul> <b>Customers may also comment on the following:</b> <ul style="list-style-type: none"><li>Oil change service light comes on at 15,000km (9,321 Miles). The actual maintenance interval for the Australian market is 20,000km (12,427 Miles).</li><li>"DEF Low Refill Soon" message will appear in the Instrument Panel Cluster (IPC).</li><li>Engine power output is lower than expected when applying the throttle.</li><li>Engine not starting.</li><li>Battery not charging.</li><li>"Engine Oil Temperature High" message in the Instrument Panel Cluster (IPC).</li><li>"Stop/Start Not Ready / Driver Seatbelt Unbuckled" message in the IPC <a href="#">Fig. 1</a>.</li><li>Vehicle will go to limp-in mode and will not go beyond 100 kmh (62 mph) speed.**</li></ul> | | | | |
