## STAR ONLINE PUBLICATION

**Case Number:** S2108000121 - Rev. B

**Symptom/Vehicle Issue:** Check Engine Light On And Service Hybrid System Displayed. P0A0A-00 High Voltage System Interlock Circuit "A" Is Active

**Discussion:** If one or more of the HVIL(High Voltage Interlock Loop) connectors was disconnected during a repair of the Hybrid System. Upon completing the repair, you may find DTC P0A0A-00 High Voltage System Interlock Circuit "A" Active even though proper torque of the HVIL connectors was achieved.

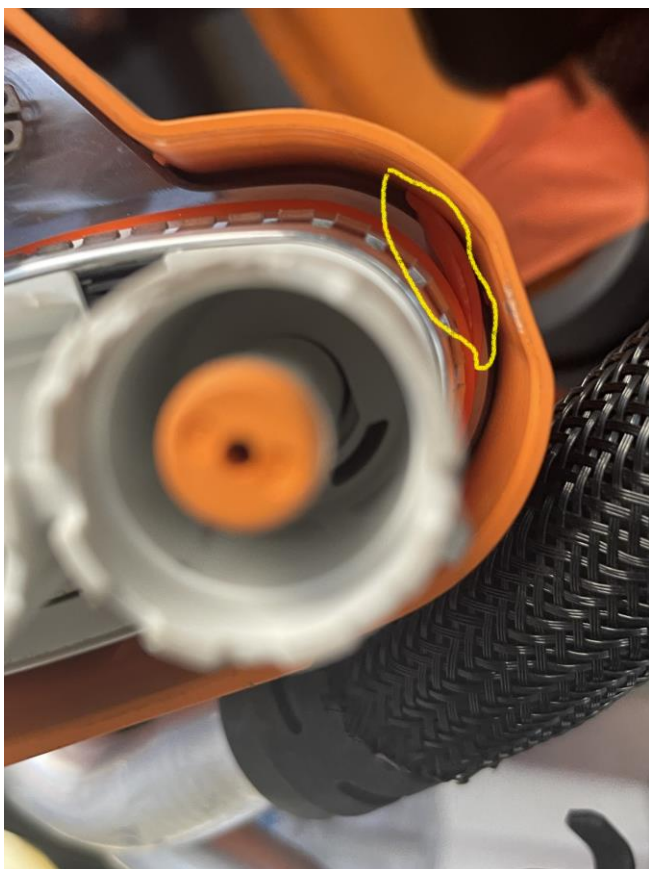
**Damaged HV Connector Seal**

Inspect the HVIL connector seals for damage or tears and the terminals for spread contacts. If any of the High Voltage connectors seals are damaged, the wiring harness will need to be replaced. If HVIL terminals appear to be spread or damaged, HV component replacement will be necessary. Contact STAR for assistance.

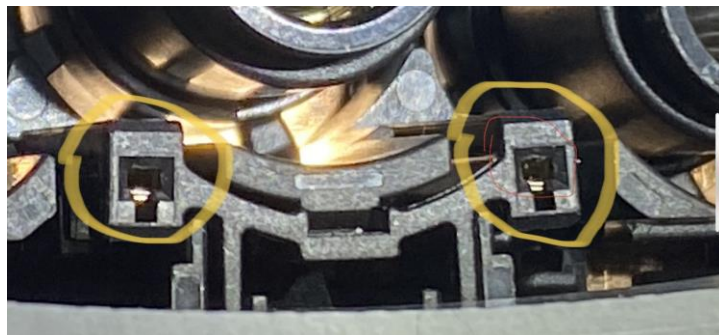
**Spread HVIL Terminals**

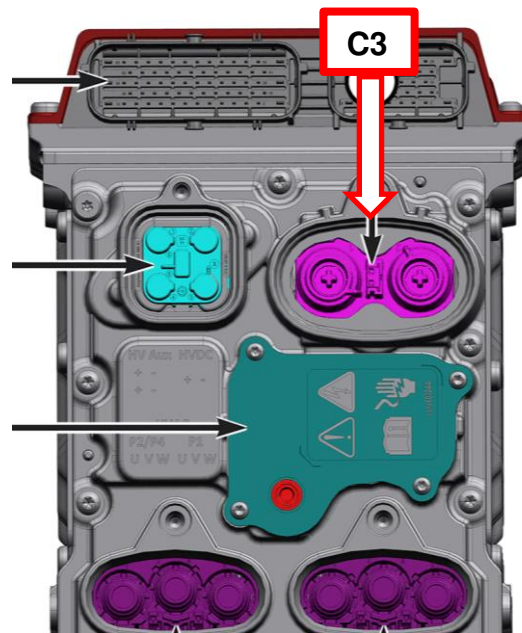
**PIM C3 Connector Location**

The Power Inverter Module (PIM) C3 connector is especially prone to being installed at an angle. Before torquing down the bolt, confirm that the C3 is fully and squarely seated by utilizing the 3 windows provided around the orange plastic colored shield of the connector. There should be no empty space when looking through the window. When fully seated, only the aluminum PIM housing should be seen. Review the images below.

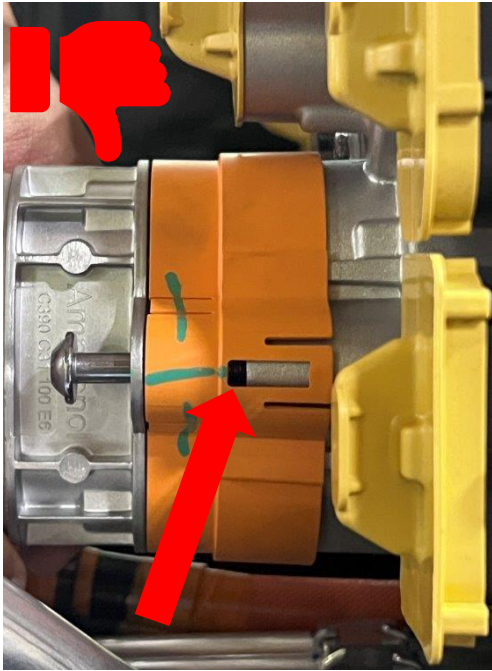
**Not Good: Air Gap in Window**

**Failure to squarely and fully seat the connector before torquing down the bolt can result in HVIL terminal damage**

Once the connector is in fully seated position, hand start the fastener and drive it until the specified torque of 80 In-Lbs. or 9 Nm is achieved.

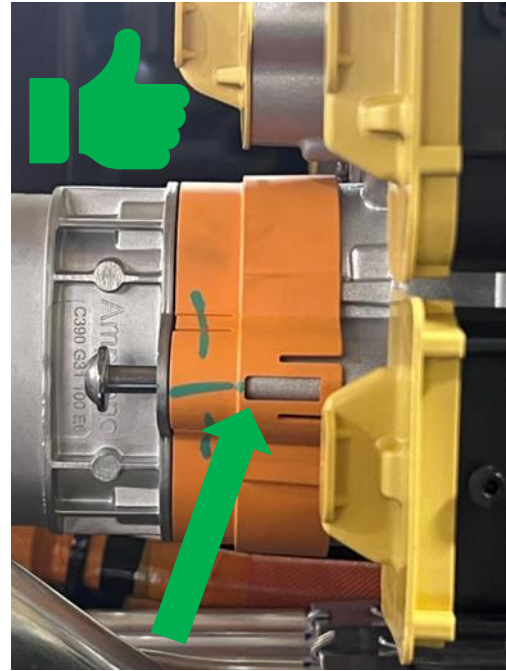
**Good: No Air Gap in Window**
