## STAR ONLINE PUBLICATION

**Case Number:** S2508000036 REV. B

**Symptom/Vehicle Issue:** The Occupant Restraint Controller (ORC) Sets B2204-00 DTC In an Unknown Status (Pending), Sets B2204-00 ECU Configuration Mismatch Or/And DTC B222D-00 Active for ECU Unable to Configure/Configuration Not Learned

**Models:** 2025 RAM (DJ,DD,D2,DP)  
2024-2025 Wagoneer S (KM)  
2024-2025 Charger (LB)

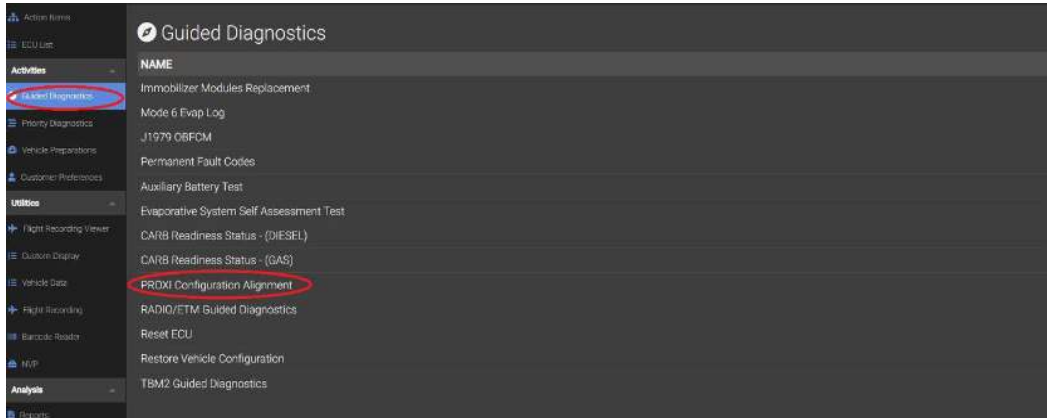
### 1- In Guided Diagnostics, Perform “PROXI Configuration Alignment”

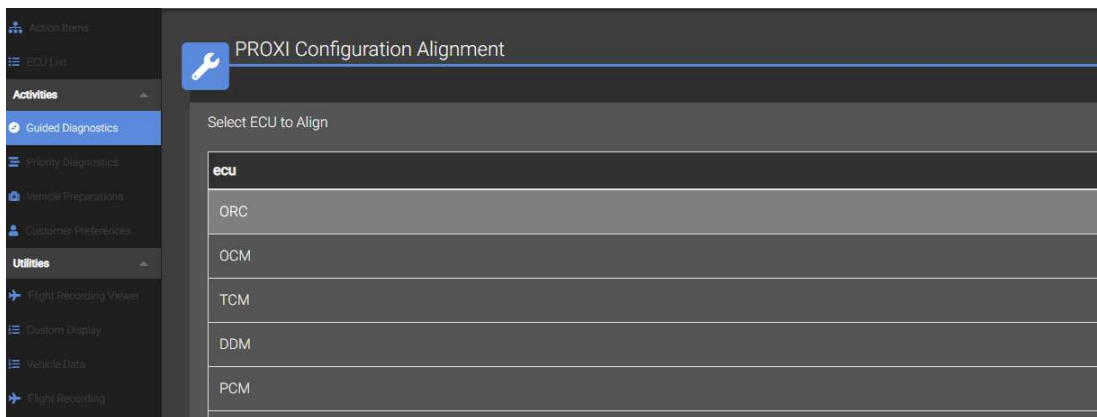
**Select ORC and click Continue to perform the alignment**
