# **HYUNDAI** **Technical Service Bulletin**

| GROUP<br><b>AUTOMATIC<br/>TRANSMISSION</b> | NUMBER<br><b>26-AT-002H</b> |
| DATE<br><b>FEBRUARY 2026</b> | MODEL(S)<br><b>SANTA FE (TMA)<br/>TUCSON (NX4A)</b> |

**SUBJECT:** ELECTRIC OIL PUMP REPLACEMENT - DTC U028700

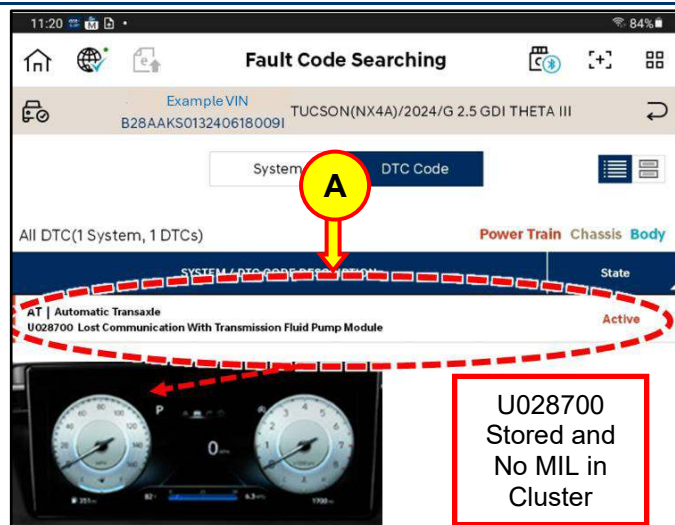
1. Using GDS, perform **Fault Code Searching** in the **AT** system for “**Active**” DTC **U028700** (Lost Communication With Trans Fluid Pump Module).

- If DTC U028700 is set in “**Active**” status (A), **proceed to step 2**.
- If DTC U028700 is **NOT** in “**Active**” status, or another DTC is found, this TSB does **NOT** apply. Follow the normal diagnostic process.
